Access Compliance Report

Public Rights-of-Way

(Curb Ramps)

Intersection ID: 15377	Main Street: ELMHURST_RD	Cross Street: HAVERFORD_PL	Location:	N
ADA ID: D512917E53A0	Ramp Type: Directional1	Initial Pass/Fail: Fail	Overall Compliance: No	Severity Score: 25

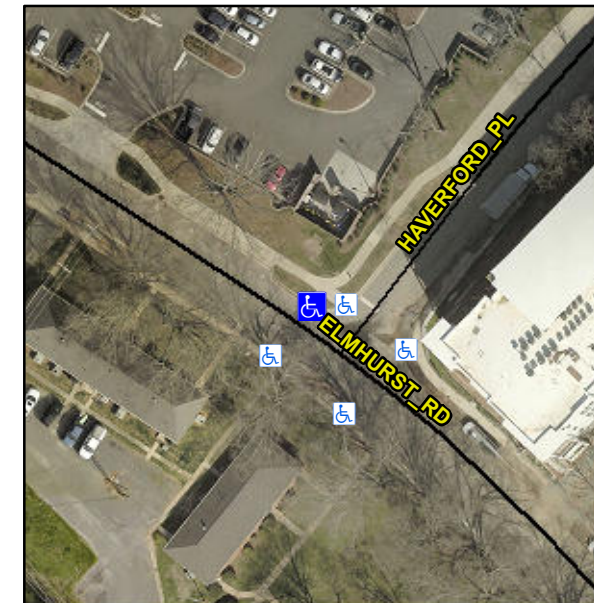
R304.2.2

Compliance	Description	Data	Compliance	Description	Data
N/A	Ramp Length (in)	78.0	N/A	Grade Break?	N/A
Yes	Ramp Width (in)	71.0	N/A	Grade Break Slope (%)	0.0
No	Ramp Slope (%)	12.1	N/A	Grade Break XSlope (%)	0.0
Yes	Ramp XSlope (%)	1.8			
N/A	Flare Type LT	N/A	N/A	Flare Type RT	N/A
N/A	Flare Slope LT (%)	N/A	N/A	Flare Slope RT (%)	0.0
N/A	Flare Traversable LT?	N/A	N/A	Flare Traversable RT?	N/A
N/A	Landing Length (in)	0.0	N/A	DWS Provided?	N/A
N/A	Landing Width (in)	0.0	N/A	DWS Contrast?	N/A
N/A	Landing Slope (%)	0.0	N/A	DWS Length (in)	N/A
N/A	Landing X Slope (%)	0.0	N/A	DWS Full Width?	N/A
N/A	Landing Curb? (Y/N)	N/A	N/A	DWS Offset LT (in)	N/A
N/A	Shared Landing?	N/A	N/A	DWS Offset RT (in)	N/A
N/A	Gutter Ponding?	0.0	N/A	Gutter Slope (%)	N/A
N/A	Gutter Lip Ht (in)	0.0	N/A	Gutter X Slope (%)	N/A
N/A	Painted X Walk1?	No		Road Slope (%)	1.1
	X Walk 1 Direction	To SW		Road X Slope (%)	1.3
	X Walk 1 Width (in)	N/A		Clear Space?	N/A

X Walk 1 Slope (%)	1.1	N/A	Clear Space to XWalk (in)	N/A
	X Walk 1 X Slope (%)	1.3	N/A	Storm Grate/Utility Hazard?	N/A
N/A	Ramp inside XWalk1?	N/A		Storm Grate/Utility Type	
N/A	Any Obstructions?	N/A			N/A
	Obstruction Type		Yes	Surface Condition? (G/P)	Good
			N/A	Curb Slope (%)	3.3

Remove & Replace Entire Ramp.

Total Cost: \$ 1600.00
