# Access Compliance Report

## Public Rights-of-Way

### (Curb Ramps)

| Intersection ID: 10028229 | Main Street: HEATHSTEAD_PL | Cross Street: N/A | Location: NW |

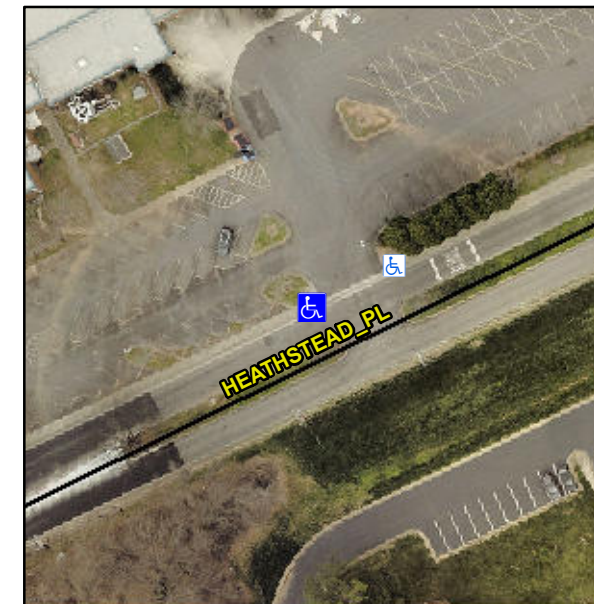
| ADA ID: D512DD98FCCE | Ramp Type: PerpDiag | Initial Pass/Fail: Fail | Overall Compliance: No |
| | | Severity Score: 25 | |

**Not Found, R304.5.3**

| Compliance | Description | Data | Compliance | Description | Data |
|---|---|---|---|---|---|
| Yes | Ramp Width (in) | 48.0 | No | Ramp XSlope (%) | 7.1 |

**Remove & Replace Curb Ramp With Two New Directional Ramps or Equivalent.**

Total Cost: \$ 3200.00
