## Access Compliance Report Public Rights-of-Way (Curb Ramps)

Intersection ID: 10040084 Main Street: TUCKASEEGEE\_RD Cross Street: N/A Location: S

ADA ID: D512F7D18884 Ramp Type: Directional1 Initial Pass/Fail: Fail Overall Compliance: No Severity Score: 33.75

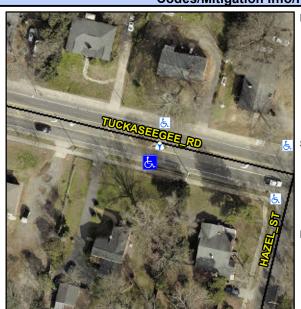
Comp	liance Description	Data	Comp	liance	Description	Data
N/A	Ramp Length (in)	47.0	N/A	Grade	e Break?	N/A
No	Ramp Width (in)	47.5	N/A	Grade	e Break Slope (%)	0.0
No	Ramp Slope (%)	13.7	N/A	Grade	e Break XSlope (%)	0.0
Yes	Ramp XSlope (%)	1.4				
N/A	Flare Type LT	N/A	N/A	Flare	Type RT	N/A
N/A	Flare Slope LT (%)	N/A	N/A	Flare	Slope RT (%)	0.0
N/A	Flare Traversable LT?	N/A	N/A	Flare	Traversable RT?	N/A
N/A	Landing Length (in)	0.0	N/A	DWS	Provided?	N/A
N/A	Landing Width (in)	0.0	N/A	DWS	Contrast?	N/A
N/A	Landing Slope (%)	0.0	N/A	DWS	Length (in)	N/A
N/A	Landing X Slope (%)	0.0	N/A	DWS	Full Width?	N/A
N/A	Landing Curb? (Y/N)	N/A	N/A	DWS	Offset LT (in)	N/A
N/A	Shared Landing?	N/A	N/A	DWS	Offset RT (in)	N/A
N/A	Gutter Ponding?	0.0	N/A	Gutte	er Slope (%)	N/A
N/A	Gutter Lip Ht (in)	0.0	N/A	Gutte	er X Slope (%)	N/A
N/A	Painted X Walk1?	No		Road	Slope (%)	5.8
	X Walk 1 Direction	To N		Road	X Slope (%)	1.3
	X Walk 1 Width (in)	N/A		Clear	Space?	N/A

X Walk 1 Slope (%)	5.8	N/A	Clear	Space to XWalk (in)	N/A
	X Walk 1 X Slope (%)	1.3	N/A	Storm	n Grate/Utility Hazard?	N/A
N/A	Ramp inside XWalk1?	N/A		Storm	n Grate/Utility Type	
N/A	Any Obstructions?	N/A				N/A
	Obstruction Type		Yes	Surfa	ce Condition? (G/P)	Good
		N/A	N/A	Curb	Slope (%)	14.

Possible Solutions:	<u>C</u>
Remove & Replace Entire Ramp.	
	N
	N
	Ye
	N
	N
Surveyor Notes:	N
N/A	N
	N
	N
	N
PROW/ADA:	N
R304.5.1, R304.2.2	N
	N
	N
	N

Total Cost:		\$	1600.00
