Access Compliance Report

Public Rights-of-Way

(Curb Ramps)

Intersection ID: 8296	Main Street: N_CRIGLER_ST	Cross Street: ROZZELLES_FERRY_RD	Location: NW
ADA ID: D51F15485474	Ramp Type: Directional1	Initial Pass/Fail: Fail	Overall Compliance: No
Severity Score: 12.5			
Codes/Mitigation Info/Possible Solution		Field Measurements/Component Compliance

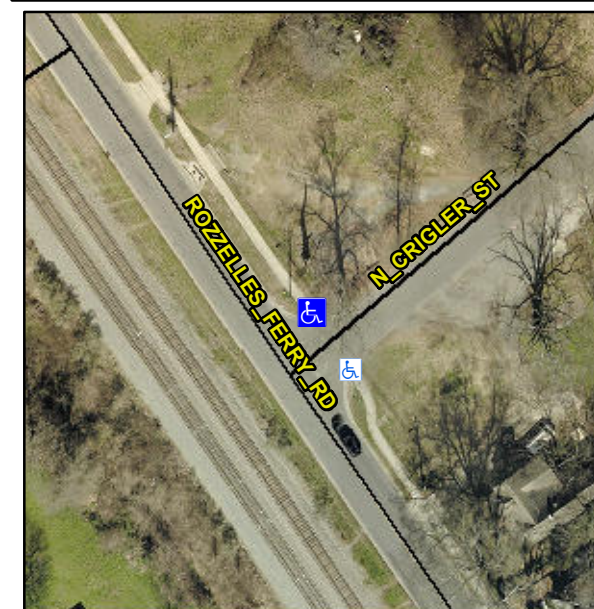
R304.2.2

Compliance	Description	Data	Compliance	Description	Data
N/A	Ramp Length (in)	93.0	N/A	Grade Break?	N/A
Yes	Ramp Width (in)	70.0	N/A	Grade Break Slope (%)	0.0
No	Ramp Slope (%)	8.6	N/A	Grade Break XSlope (%)	0.0
Yes	Ramp XSlope (%)	0.1			
N/A	Flare Type LT	N/A	N/A	Flare Type RT	N/A
N/A	Flare Slope LT (%)	N/A	N/A	Flare Slope RT (%)	0.0
N/A	Flare Traversable LT?	N/A	N/A	Flare Traversable RT?	N/A
N/A	Landing Length (in)	0.0	N/A	DWS Provided?	N/A
N/A	Landing Width (in)	0.0	N/A	DWS Contrast?	N/A
N/A	Landing Slope (%)	0.0	N/A	DWS Length (in)	N/A
N/A	Landing X Slope (%)	0.0	N/A	DWS Full Width?	N/A
N/A	Landing Curb? (Y/N)	N/A	N/A	DWS Offset LT (in)	N/A
N/A	Shared Landing?	N/A	N/A	DWS Offset RT (in)	N/A
N/A	Gutter Ponding?	0.0	N/A	Gutter Slope (%)	N/A
N/A	Gutter Lip Ht (in)	0.0	N/A	Gutter X Slope (%)	N/A
N/A	Painted X Walk1?	No		Road Slope (%)	1.6
	X Walk 1 Direction	To SE		Road X Slope (%)	2.3
	X Walk 1 Width (in)	N/A		Clear Space?	N/A

X Walk 1 Slope (%)	1.6	N/A	Clear Space to XWalk (in)	N/A
	X Walk 1 X Slope (%)	2.3	N/A	Storm Grate/Utility Hazard?	N/A
N/A	Ramp inside XWalk1?	N/A		Storm Grate/Utility Type	
N/A	Any Obstructions?	N/A			N/A
	Obstruction Type		Yes	Surface Condition? (G/P)	Good
			N/A	Curb Slope (%)	11.5

Remove & Replace Entire Ramp.

Total Cost: \$ 1600.00
