Access Compliance Report

Public Rights-of-Way

(Curb Ramps)

Intersection ID: 28440	Main Street: DEARMON_RD	Cross Street: PROSPERITY_VILLAGE_DR	Location: N
ADA ID: D53D049A175E	Ramp Type: Perp	Initial Pass/Fail: Fail	Overall Compliance: No
Severity Score: 58.75			
Codes/Mitigation Info/Possible Solution		Field Measurements/Component Compliance

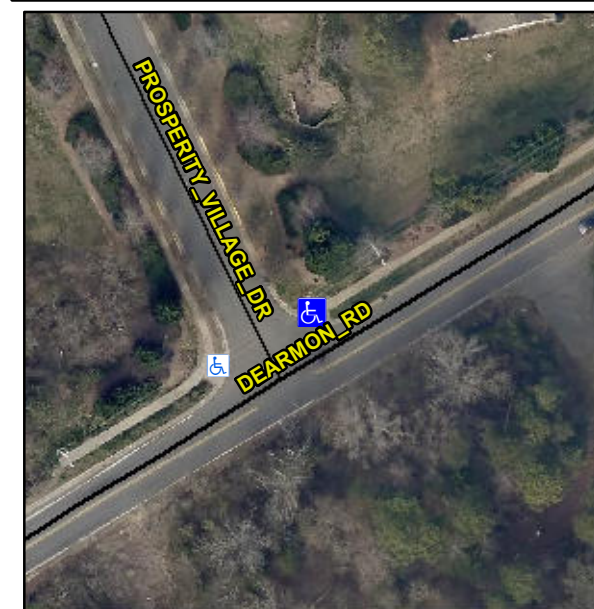
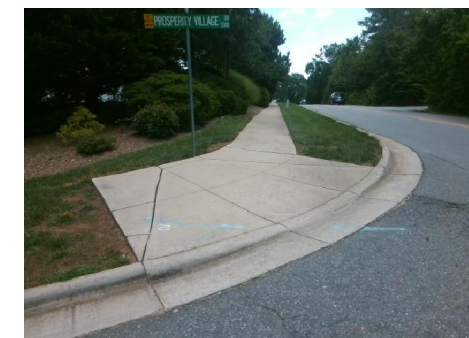
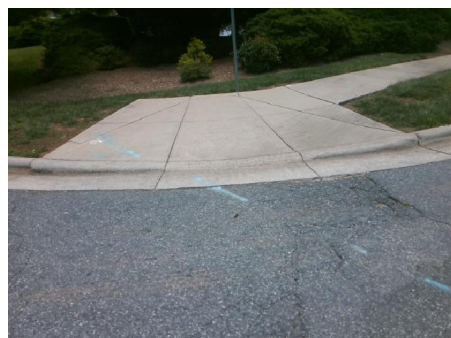
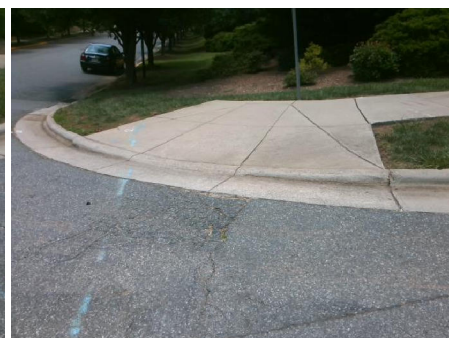
R304.5.1, R304.2.2, R304.5.3

Compliance	Description	Data	Compliance	Description	Data
N/A	Ramp Length (in)	124.5	No	Ramp Slope (%)	14.7
No	Ramp Width (in)	37.0	No	Ramp XSlope (%)	15.0
N/A	Flare Type LT	N/A	N/A	Flare Type RT	N/A
N/A	Flare Slope LT (%)	N/A	N/A	Flare Slope RT (%)	N/A
N/A	Flare Traversable LT?	N/A	N/A	Flare Traversable RT?	N/A
N/A	Landing Length (in)	N/A	N/A	DWS Provided?	N/A
N/A	Landing Width (in)	N/A	N/A	DWS Contrast?	N/A
N/A	Landing Slope (%)	N/A	N/A	DWS Length (in)	N/A
N/A	Landing X Slope (%)	N/A	N/A	DWS Full Width?	N/A
N/A	Landing Curb? (Y/N)	N/A	N/A	DWS Offset (in)	N/A
N/A	Shared Landing?	N/A			
N/A	Gutter Ponding?	N/A	N/A	Gutter Slope (%)	N/A
N/A	Gutter Lip Ht (in)	N/A	N/A	Gutter X Slope (%)	N/A
N/A	Painted X Walk1?	No	N/A	Painted X Walk2?	N/A
	X Walk 1 Direction	To SW		X Walk 2 Direction	N/A
N/A	X Walk 1 Width (in)	N/A	N/A	X Walk 2 Width (in)	N/A
	X Walk 1 Slope (%)	13.7		X Walk 2 Slope (%)	N/A
	X Walk 1 X Slope (%)	12.8		X Walk 2 X Slope (%)	N/A

N/A	Ramp inside XWalk1?	N/A	N/A	Ramp inside XWalk2?	N/A
	Road Slope (%)	N/A	N/A	Clear Space?	N/A
	Road X Slope (%)	N/A	N/A	Clear Space to XWalk (in)	N/A
N/A	Any Obstructions?	N/A	N/A	Storm Grate/Utility Hazard?	N/A
	Obstruction Type			Storm Grate/Utility Type	
		N/A			N/A
			Yes	Surface Condition? (G/P)	Good

Possible Solutions:

Remove & Replace Entire Ramp.
