Intersection ID: 13121	Main Street: OLD_STEELE_CREEK_RD	Cross Street: PRIMROSE_AV	Location:	SW
ADA ID: D53E480B4824	Ramp Type: PerpDiag	Initial Pass/Fail: Fail	Overall Compliance: No	Severity Score: 22.5

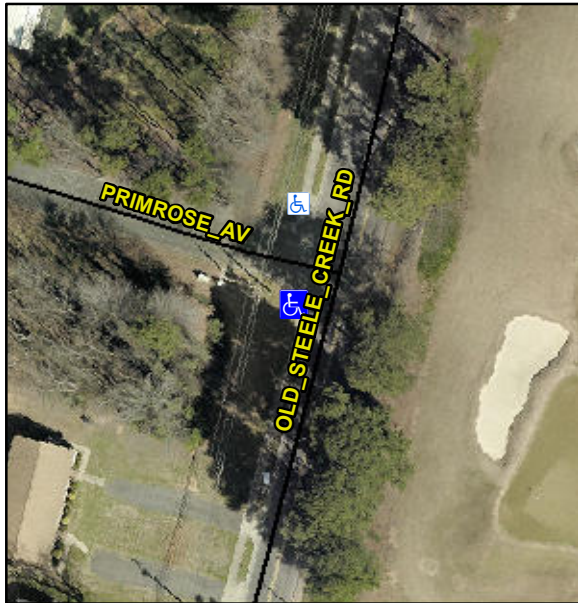
**Not Found, R304.5.1, R304.2.2,
R304.5.3**

Compliance	Description	Data	Compliance	Description	Data
N/A	Ramp Length (in)	61.0	No	Ramp Slope (%)	9.0
No	Ramp Width (in)	46.0	No	Ramp XSlope (%)	3.5
N/A	Flare Type LT	N/A	N/A	Flare Type RT	N/A
N/A	Flare Slope LT (%)	N/A	N/A	Flare Slope RT (%)	N/A
N/A	Flare Traversable LT?	N/A	N/A	Flare Traversable RT?	N/A
N/A	Landing Length (in)	N/A	N/A	DWS Provided?	N/A
N/A	Landing Width (in)	N/A	N/A	DWS Contrast?	N/A
N/A	Landing Slope (%)	N/A	N/A	DWS Length (in)	N/A
N/A	Landing X Slope (%)	N/A	N/A	DWS Full Width?	N/A
N/A	Landing Curb? (Y/N)	N/A	N/A	DWS Offset (in)	N/A
N/A	Shared Landing?	N/A			
N/A	Gutter Ponding?	N/A	N/A	Gutter Slope (%)	N/A
N/A	Gutter Lip Ht (in)	N/A	N/A	Gutter X Slope (%)	N/A
N/A	Painted X Walk1?	No	N/A	Painted X Walk2?	No
	X Walk 1 Direction	To E		X Walk 2 Direction	To N
N/A	X Walk 1 Width (in)	N/A	N/A	X Walk 2 Width (in)	N/A
	X Walk 1 Slope (%)	3.1		X Walk 2 Slope (%)	1.3
	X Walk 1 X Slope (%)	3.0		X Walk 2 X Slope (%)	2.4

N/A	Ramp inside XWalk1?	N/A	N/A	Ramp inside XWalk2?	N/A
	Road Slope (%)	1.0	N/A	Clear Space?	N/A
	Road X Slope (%)	3.9	N/A	Clear Space to XWalk (in)	N/A
N/A	Any Obstructions?	N/A	N/A	Storm Grate/Utility Hazard?	N/A
	Obstruction Type			Storm Grate/Utility Type	
		N/A			N/A
			Yes	Surface Condition? (G/P)	Good

Possible Solutions:

Remove & Replace Curb Ramp With Two New Directional Ramps or Equivalent.
