## Access Compliance Report Public Rights-of-Way (Curb Ramps)

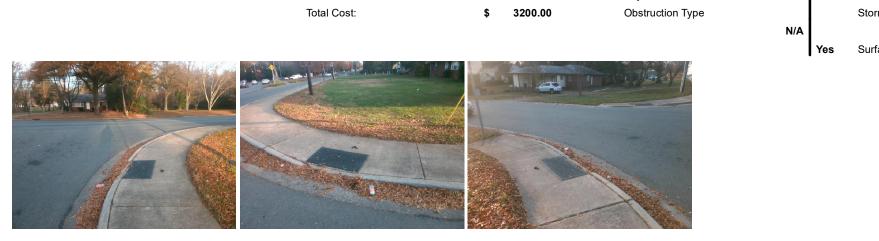
· · · · · · · · · · · · · · · · · · ·									
Intersection ID: 16218	Intersection ID: 16218 Main Street: E_W_T_HARRIS_BV			Street:	ELWOOD_DR	Location:	NE		
ADA ID: D550E7F81CB8	: D550E7F81CB8 Ramp Type: PerpDiag			itial Pass/Fail: Fail Overall Compliance: No				o Severity Score:	22.5
Codes/Mitigation Info/Possible Solution				Field Measurements/Component Compliance					
		Possible Solutions:					a Compliance Description		Data
	6	Remove & Replace Curb Ramp	With	N/A	Ramp Length (in)	60.0	No	Ramp Slope (%)	9.6
		Two New Directional Ramps or	••••	No	Ramp Width (in)	39.0		Ramp XSlope (%)	4.4
		Equivalent.		N/A	Flare Type LT	N/A		Flare Type RT	N/A
				N/A	Flare Slope LT (%)	N/A	N/A	Flare Slope RT (%)	N/A
	Caller 1 S. a			N/A	Flare Traversable LT?	N/A	N/A	Flare Traversable RT?	N/A
	and the			N/A	Landing Length (in)	N/A	N/A	DWS Provided?	N/A
	the second second	Surveyor Notes:		N/A	Landing Width (in)	N/A	N/A	DWS Contrast?	N/A

and the	N/A		N/A	Landing Slope (%)	N/A	N/A	DWS Length (in)	N/A
	EUVIDE			N/A	Landing X Slope (%)	N/A	N/A	DWS Full Width?	N/A
PROW/ADA: Not Found, R304.5.1, R304.2.2, R304.5.3				N/A	Landing Curb? (Y/N)	N/A	N/A	DWS Offset (in)	N/A
				N/A	Shared Landing?	N/A			
				N/A	Gutter Ponding?	N/A	N/A	Gutter Slope (%)	N/A
				N/A	Gutter Lip Ht (in)	N/A	N/A	Gutter X Slope (%)	N/A
				N/A	Painted X Walk1?	No	N/A	Painted X Walk2?	No
					X Walk 1 Direction	To NW		X Walk 2 Direction	To SW
			N/A	X Walk 1 Width (in)	N/A	N/A	X Walk 2 Width (in)	N/A	
Street 1 Name	E W T HARRIS BV	-			X Walk 1 Slope (%)	6.8		X Walk 2 Slope (%)	6.2
Stop Condition-Street 2	None				X Walk 1 X Slope (%)	5.0		X Walk 2 X Slope (%)	5.0
Street 2 Name	ELWOOD DR			N/A	Ramp inside XWalk1?	N/A	N/A	Ramp inside XWalk2?	N/A
Stop Condition-Street 1	StopSign				Road Slope (%)	3.3	N/A	Clear Space?	N/A
					Road X Slope (%)	8.9	N/A	Clear Space to XWalk (in)	N/A

N/A	Any Obstructions?	N/A	N/A	Storm Grate/Utility Hazard?	N/A
		Total Cost: \$	3200.00		Obstruction Type			Storm Grate/Utility Type	
						N/A			N/A
							1
