Access Compliance Report Public Rights-of-Way (Curb Ramps)

Cross Street: N/A Intersection ID: 10035091 Main Street: PROVIDENCE RD Location: W ADA ID: D55B3818F241 Ramp Type: Perp Initial Pass/Fail: Fail **Overall Compliance: No Severity Score:** 10

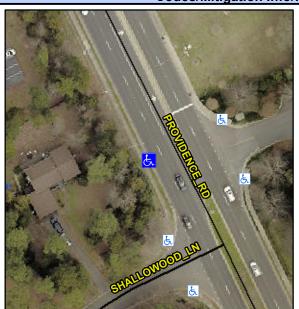
Field Measurements/Component Compliance									
	Compl	liance Description	Data	Comp	liance Description	Data			
	N/A	Ramp Length (in)	85.0	Yes	Ramp Slope (%)	7.7			
	No	Ramp Width (in)	46.0	No	Ramp XSlope (%)	2.9			
	N/A	Flare Type LT	N/A	N/A	Flare Type RT	N/A			
	N/A	Flare Slope LT (%)	N/A	N/A	Flare Slope RT (%)	N/A			
	N/A	Flare Traversable LT?	N/A	N/A	Flare Traversable RT?	N/A			
	N/A	Landing Length (in)	N/A	N/A	DWS Provided?	N/A			
	N/A	Landing Width (in)	N/A	N/A	DWS Contrast?	N/A			
	N/A	Landing Slope (%)	N/A	N/A	DWS Length (in)	N/A			
	N/A	Landing X Slope (%)	N/A	N/A	DWS Full Width?	N/A			
	N/A	Landing Curb? (Y/N)	N/A	N/A	DWS Offset (in)	N/A			
	N/A	Shared Landing?	N/A						
	N/A	Gutter Ponding?	N/A	N/A	Gutter Slope (%)	N/A			
	N/A	Gutter Lip Ht (in)	N/A	N/A	Gutter X Slope (%)	N/A			
	N/A	Painted X Walk1?	No	N/A	Painted X Walk2?	N/A			
		X Walk 1 Direction	To NE		X Walk 2 Direction	N/A			
	N/A	X Walk 1 Width (in)	N/A	N/A	X Walk 2 Width (in)	N/A

X Walk 1 Slope (%)	0.9		X Walk 2 Slope (%)	N/A			
		X Walk 1 X Slope (%)	2.2		X Walk 2 X Slope (%)	N/A			
	N/A	Ramp inside XWalk1?	N/A	N/A	Ramp inside XWalk2?	N/A			
		Road Slope (%)	N/A	N/A	Clear Space?	N/A			
		Road X Slope (%)	N/A	N/A	Clear Space to XWalk (in)	N/A			
	N/A	Any Obstructions?	N/A	N/A	Storm Grate/Utility Hazard?	N/A			
		Obstruction Type			Storm Grate/Utility Type				
			N/A			N/A			
				Yes	Surface Condition? (G/P)	Good

Possible Solutions:						
Remove & Replace Entire Ramp.						
Ourse Notes						
Surveyor Notes:						
N/A						
PROW/ADA:						
Not Found, R304.5.1, R304.5.3						
,
