Intersection ID: 3742	Main Street: GALLOWAY_RD	Cross Street: TRADITION_VIEW_DR	Location:	S
ADA ID: D569F83D3EEA	Ramp Type: Perp	Initial Pass/Fail: Fail	Overall Compliance: No	Severity Score: 10

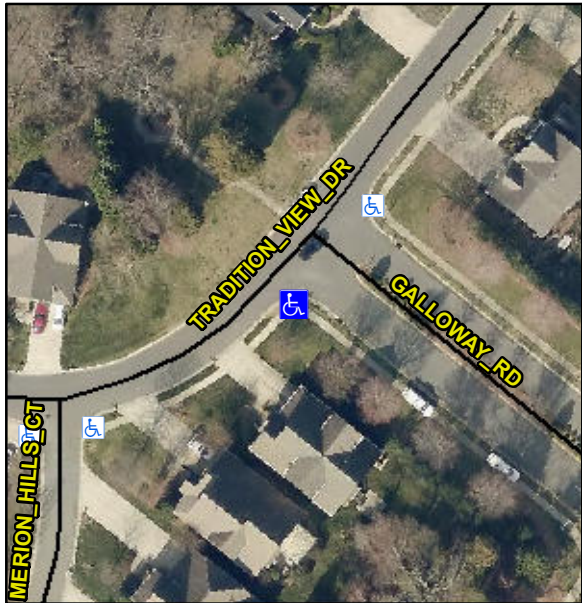
Possible Solutions:		Compliance	Description	Data	Compliance	Description	Data
	Remove & Replace Entire Ramp.		N/A	Ramp Length (in)	96.0	Yes	Ramp Slope (%)	7.9
			No	Ramp Width (in)	45.0	No	Ramp XSlope (%)	3.4
			N/A	Flare Type LT	N/A	N/A	Flare Type RT	N/A
			N/A	Flare Slope LT (%)	N/A	N/A	Flare Slope RT (%)	N/A
			N/A	Flare Traversable LT?	N/A	N/A	Flare Traversable RT?	N/A
			N/A	Landing Length (in)	N/A	N/A	DWS Provided?	N/A
Surveyor Notes:			N/A	Landing Width (in)	N/A	N/A	DWS Contrast?	N/A
	N/A		N/A	Landing Slope (%)	N/A	N/A	DWS Length (in)	N/A
			N/A	Landing X Slope (%)	N/A	N/A	DWS Full Width?	N/A
			N/A	Landing Curb? (Y/N)	N/A	N/A	DWS Offset (in)	N/A
			N/A	Shared Landing?	N/A			
PROW/ADA:			N/A	Gutter Ponding?	N/A	N/A	Gutter Slope (%)	N/A
	Not Found, R304.5.1, R304.5.3		N/A	Gutter Lip Ht (in)	N/A	N/A	Gutter X Slope (%)	N/A

N/A	Painted X Walk1?	No	N/A	Painted X Walk2?	N/A
				X Walk 1 Direction	To NE		X Walk 2 Direction	N/A
			N/A	X Walk 1 Width (in)	N/A	N/A	X Walk 2 Width (in)	N/A
				X Walk 1 Slope (%)	4.7		X Walk 2 Slope (%)	N/A
				X Walk 1 X Slope (%)	0.8		X Walk 2 X Slope (%)	N/A
			N/A	Ramp inside XWalk1?	N/A	N/A	Ramp inside XWalk2?	N/A
				Road Slope (%)	N/A	N/A	Clear Space?	N/A
				Road X Slope (%)	N/A	N/A	Clear Space to XWalk (in)	N/A
			N/A	Any Obstructions?	N/A	N/A	Storm Grate/Utility Hazard?	N/A
				Obstruction Type			Storm Grate/Utility Type	
Total Cost:	\$ 1850.00				N/A			N/A
						Yes	Surface Condition? (G/P)	Good
