## Access Compliance Report Public Rights-of-Way (Curb Ramps)

Intersection ID: 2949 Main Street: DOWNFIELD\_WOOD\_DR Cross Street: LADY\_BANK\_DR Location: W

ADA ID: D56BBDE7A8B6 Ramp Type: Perp Initial Pass/Fail: Fail Overall Compliance: No Severity Score: 12.5

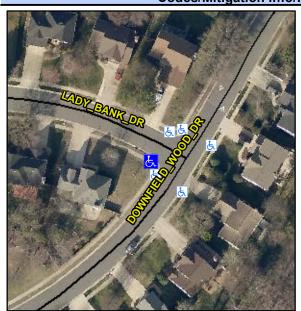
Not Found, R304.2.2

No N/A Ramp Length (in) 54.0 Ramp Slope (%) 9.3 Ramp XSlope (%) Yes Ramp Width (in) 84.0 Yes 1.7 N/A N/A Flare Type LT N/A Flare Type RT N/A N/A N/A N/A Flare Slope RT (%) Flare Slope LT (%) N/A N/A Flare Traversable LT? N/A N/A Flare Traversable RT? N/A N/A N/A N/A **DWS Provided?** N/A Landing Length (in) N/A Landing Width (in) N/A N/A **DWS Contrast?** N/A N/A N/A N/A Landing Slope (%) DWS Length (in) N/A N/A Landing X Slope (%) N/A N/A DWS Full Width? N/A N/A Landing Curb? (Y/N) N/A N/A DWS Offset (in) N/A N/A N/A Shared Landing? N/A **Gutter Ponding?** N/A N/A Gutter Slope (%) N/A N/A Gutter Lip Ht (in) N/A N/A Gutter X Slope (%) N/A N/A Painted X Walk1? No N/A Painted X Walk2? N/A X Walk 1 Direction To NE X Walk 2 Direction N/A N/A N/A X Walk 1 Width (in) X Walk 2 Width (in) N/A X Walk 1 Slope (%) X Walk 2 Slope (%) N/A 0.4 X Walk 1 X Slope (%) 1.5 X Walk 2 X Slope (%) N/A N/A N/A N/A Ramp inside XWalk2? Ramp inside XWalk1? N/A Road Slope (%) N/A N/A Clear Space? N/A Road X Slope (%) N/A N/A Clear Space to XWalk (in) N/A N/A N/A Any Obstructions? N/A Storm Grate/Utility Hazard? N/A **Obstruction Type** Storm Grate/Utility Type N/A N/A Yes Surface Condition? (G/P) Good

Possible Solutions:

Remove & Replace Entire Ramp.

Total Cost: \$ 1850.00
