Access Compliance Report

Public Rights-of-Way

(Curb Ramps)

Intersection ID: 29145	Main Street: CRAWFORD_BROOK_LN	Cross Street: DEATON_HILL_DR	Location: SE
ADA ID: D57A5E823F1B	Ramp Type: PerpDiag	Initial Pass/Fail: Fail	Overall Compliance: No
Severity Score: 10			
Codes/Mitigation Info/Possible Solution		Field Measurements/Component Compliance

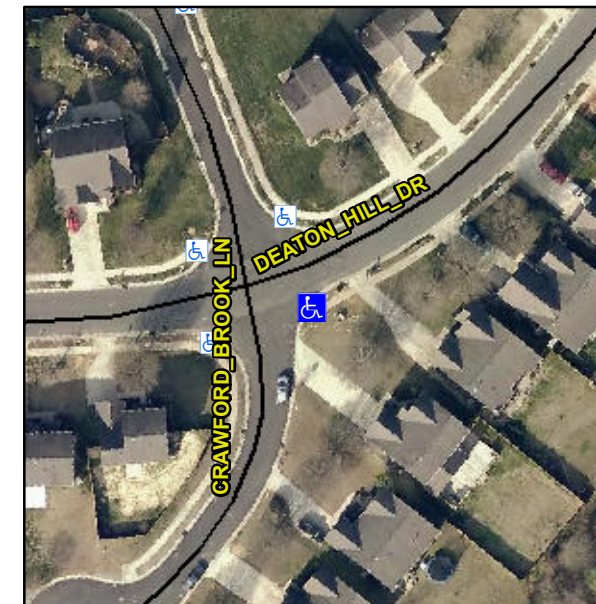
Not Found, R304.5.1, R304.5.3

Compliance	Description	Data	Compliance	Description	Data
N/A	Ramp Length (in)	48.0	Yes	Ramp Slope (%)	6.0
No	Ramp Width (in)	47.0	No	Ramp XSlope (%)	2.5
N/A	Flare Type LT	N/A	N/A	Flare Type RT	N/A
N/A	Flare Slope LT (%)	N/A	N/A	Flare Slope RT (%)	N/A
N/A	Flare Traversable LT?	N/A	N/A	Flare Traversable RT?	N/A
N/A	Landing Length (in)	N/A	N/A	DWS Provided?	N/A
N/A	Landing Width (in)	N/A	N/A	DWS Contrast?	N/A
N/A	Landing Slope (%)	N/A	N/A	DWS Length (in)	N/A
N/A	Landing X Slope (%)	N/A	N/A	DWS Full Width?	N/A
N/A	Landing Curb? (Y/N)	N/A	N/A	DWS Offset (in)	N/A
N/A	Shared Landing?	N/A			
N/A	Gutter Ponding?	N/A	N/A	Gutter Slope (%)	N/A
N/A	Gutter Lip Ht (in)	N/A	N/A	Gutter X Slope (%)	N/A
N/A	Painted X Walk1?	No	N/A	Painted X Walk2?	No
	X Walk 1 Direction	To N		X Walk 2 Direction	To W
N/A	X Walk 1 Width (in)	N/A	N/A	X Walk 2 Width (in)	N/A
	X Walk 1 Slope (%)	1.8		X Walk 2 Slope (%)	4.9
	X Walk 1 X Slope (%)	4.4		X Walk 2 X Slope (%)	0.5

N/A	Ramp inside XWalk1?	N/A	N/A	Ramp inside XWalk2?	N/A
	Road Slope (%)	2.7	N/A	Clear Space?	N/A
	Road X Slope (%)	3.8	N/A	Clear Space to XWalk (in)	N/A
N/A	Any Obstructions?	N/A	N/A	Storm Grate/Utility Hazard?	N/A
	Obstruction Type			Storm Grate/Utility Type	
		N/A			N/A
			Yes	Surface Condition? (G/P)	Good

Possible Solutions:

Remove & Replace Curb Ramp With Two New Directional Ramps or Equivalent.
