Access Compliance Report

Public Rights-of-Way

(Curb Ramps)

Intersection ID: 8616	Main Street: BEATTIES_FORD_RD	Cross Street: ST_MARK_ST	Location: SE
ADA ID: D57C131570A2	Ramp Type: BlendTrans1	Initial Pass/Fail: Fail	Overall Compliance: No
Codes/Mitigation Info/Possible Solution			Severity Score: 10
			Field Measurements/Component Compliance

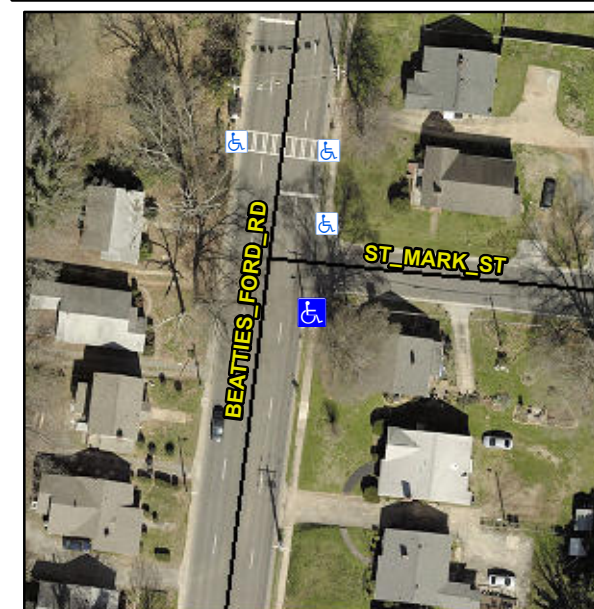
NO LT SW

Not Found, R304.5.1, R304.5.3

Compliance	Description	Data	Compliance	Description	Data
N/A	Ramp Length (in)	26.0	Yes	BlendTrans Slope (%)	4.5
No	Ramp Width (in)	47.5	No	BlendTrans XSlope (%)	4.6
N/A	Flare Type LT	N/A	N/A	Flare Type RT	N/A
N/A	Flare Slope LT (%)	N/A	N/A	Flare Slope RT (%)	N/A
N/A	Flare Traversable LT?	N/A	N/A	Flare Traversable RT?	N/A
N/A	Landing Length (in)	N/A	N/A	DWS Provided?	N/A
N/A	Landing Width (in)	N/A	N/A	DWS Contrast?	N/A
N/A	Landing Slope (%)	N/A	N/A	DWS Length (in)	N/A
N/A	Landing X Slope (%)	N/A	N/A	DWS Full Width?	N/A
N/A	Landing Curb? (Y/N)	N/A	N/A	DWS Offset (in)	N/A
N/A	Shared Landing?	N/A			
N/A	Gutter Ponding?	N/A	N/A	Gutter Slope (%)	N/A
N/A	Gutter Lip Ht (in)	N/A	N/A	Gutter X Slope (%)	N/A
N/A	Painted X Walk1?	No	N/A	Painted X Walk2?	N/A
	X Walk 1 Direction	To N		X Walk 2 Direction	N/A
	X Walk 1 Width (in)	N/A		X Walk 2 Width (in)	N/A
	X Walk 1 Slope (%)	1.9		X Walk 2 Slope (%)	N/A
	X Walk 1 X Slope (%)	8.0		X Walk 2 X Slope (%)	N/A

N/A	Ramp inside XWalk1?	N/A	N/A	Ramp inside XWalk2?	N/A
	Road Slope (%)	8.0		Clear Space?	N/A
	Road X Slope (%)	1.9	N/A	Clear Space to XWalk (in)	N/A
N/A	Any Obstructions?	N/A	N/A	Storm Grate/Utility Hazard?	N/A
	Obstruction Type			Storm Grate/Utility Type	
		N/A			N/A
			Yes	Surface Condition? (G/P)	Good
			No	Curb Slope (%)	17.3

Possible Solutions:

Remove & Replace Curb Ramp With Two New Directional Ramps or Equivalent.
