# Access Compliance Report

## Public Rights-of-Way

### (Curb Ramps)

Intersection ID: 30165	Main Street: BIESTERFIELD_DR	Cross Street: OLDE_ENGLISH_DR	Location: SW
ADA ID: D5AF2095ADD7	Ramp Type: PerpDiag	Initial Pass/Fail: Fail	Overall Compliance: No
		Severity Score: 10

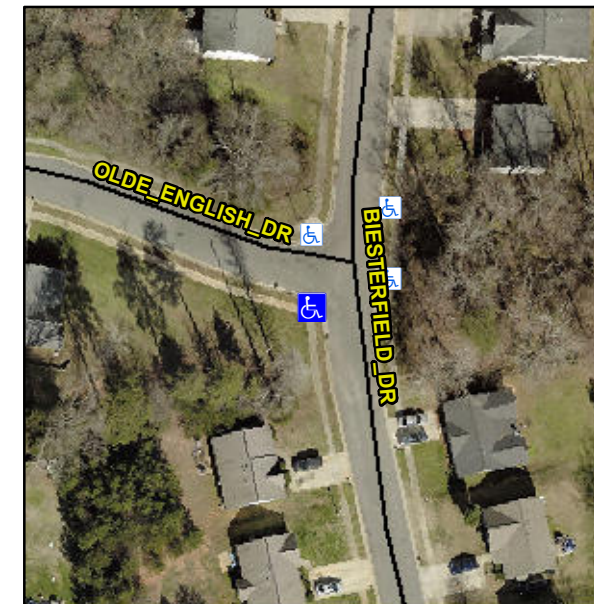
**Not Found, R304.5.1, R304.5.3**

Compliance	Description	Data	Compliance	Description	Data
N/A	Ramp Length (in)	46.5	Yes	Ramp Slope (%)	7.1
No	Ramp Width (in)	36.0	No	Ramp XSlope (%)	4.4
N/A	Flare Type LT	N/A	N/A	Flare Type RT	N/A
N/A	Flare Slope LT (%)	N/A	N/A	Flare Slope RT (%)	N/A
N/A	Flare Traversable LT?	N/A	N/A	Flare Traversable RT?	N/A
N/A	Landing Length (in)	N/A	N/A	DWS Provided?	N/A
N/A	Landing Width (in)	N/A	N/A	DWS Contrast?	N/A
N/A	Landing Slope (%)	N/A	N/A	DWS Length (in)	N/A
N/A	Landing X Slope (%)	N/A	N/A	DWS Full Width?	N/A
N/A	Landing Curb? (Y/N)	N/A	N/A	DWS Offset (in)	N/A
N/A	Shared Landing?	N/A			
N/A	Gutter Ponding?	N/A	N/A	Gutter Slope (%)	N/A
N/A	Gutter Lip Ht (in)	N/A	N/A	Gutter X Slope (%)	N/A
N/A	Painted X Walk1?	No	N/A	Painted X Walk2?	No
	X Walk 1 Direction	To SE		X Walk 2 Direction	To NW
N/A	X Walk 1 Width (in)	N/A	N/A	X Walk 2 Width (in)	N/A
	X Walk 1 Slope (%)	3.8		X Walk 2 Slope (%)	0.0
	X Walk 1 X Slope (%)	1.7		X Walk 2 X Slope (%)	1.8

N/A	Ramp inside XWalk1?	N/A	N/A	Ramp inside XWalk2?	N/A
	Road Slope (%)	3.2	N/A	Clear Space?	N/A
	Road X Slope (%)	4.5	N/A	Clear Space to XWalk (in)	N/A
N/A	Any Obstructions?	N/A	N/A	Storm Grate/Utility Hazard?	N/A
	Obstruction Type			Storm Grate/Utility Type	
		N/A			N/A
			Yes	Surface Condition? (G/P)	Good

**Remove & Replace Curb Ramp With Two New Directional Ramps or Equivalent.**
