# Access Compliance Report

## Public Rights-of-Way

### (Curb Ramps)

Intersection ID: 10041631	Main Street: WHITEHALL_PARK_DR	Cross Street: N/A	Location: NW
ADA ID: D5B359A680C8	Ramp Type: PerpDiag	Initial Pass/Fail: Fail	Overall Compliance: No
Severity Score: 22.5			
Codes/Mitigation Info/Possible Solution		Field Measurements/Component Compliance

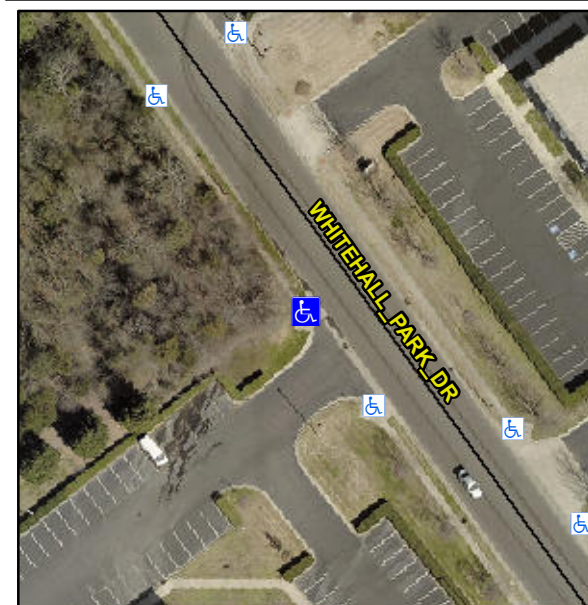
Compliance	Description	Data	Compliance	Description	Data
N/A	Ramp Length (in)	47.0	No	Ramp Slope (%)	8.8
No	Ramp Width (in)	47.0	No	Ramp XSlope (%)	2.1
N/A	Flare Type LT	N/A	N/A	Flare Type RT	N/A
N/A	Flare Slope LT (%)	N/A	N/A	Flare Slope RT (%)	N/A
N/A	Flare Traversable LT?	N/A	N/A	Flare Traversable RT?	N/A
N/A	Landing Length (in)	N/A	N/A	DWS Provided?	N/A
N/A	Landing Width (in)	N/A	N/A	DWS Contrast?	N/A
N/A	Landing Slope (%)	N/A	N/A	DWS Length (in)	N/A
N/A	Landing X Slope (%)	N/A	N/A	DWS Full Width?	N/A
N/A	Landing Curb? (Y/N)	N/A	N/A	DWS Offset (in)	N/A
N/A	Shared Landing?	N/A			
N/A	Gutter Ponding?	N/A	N/A	Gutter Slope (%)	N/A
N/A	Gutter Lip Ht (in)	N/A	N/A	Gutter X Slope (%)	N/A
N/A	Painted X Walk1?	No	N/A	Painted X Walk2?	No
	X Walk 1 Direction	To SE		X Walk 2 Direction	To NE
N/A	X Walk 1 Width (in)	N/A	N/A	X Walk 2 Width (in)	N/A
	X Walk 1 Slope (%)	0.3		X Walk 2 Slope (%)	2.5
	X Walk 1 X Slope (%)	3.1		X Walk 2 X Slope (%)	1.7

N/A	Ramp inside XWalk1?	N/A	N/A	Ramp inside XWalk2?	N/A
	Road Slope (%)	1.8	N/A	Clear Space?	N/A
	Road X Slope (%)	3.8	N/A	Clear Space to XWalk (in)	N/A
N/A	Any Obstructions?	N/A	N/A	Storm Grate/Utility Hazard?	N/A
	Obstruction Type			Storm Grate/Utility Type	
		N/A			N/A
			Yes	Surface Condition? (G/P)	Good

Possible Solutions:

**Remove & Replace Curb Ramp With Two New Directional Ramps or Equivalent.**

**R304.5.1, R304.2.2, R304.5.3**
