# Access Compliance Report

## Public Rights-of-Way

### (Curb Ramps)

Intersection ID: 12438	Main Street: E_8TH_ST	Cross Street: N_DAVIDSON_ST	Location: W
ADA ID: D5B60BE98A01	Ramp Type: PerpDiag	Initial Pass/Fail: Fail	Overall Compliance: No
		Severity Score: 8.75

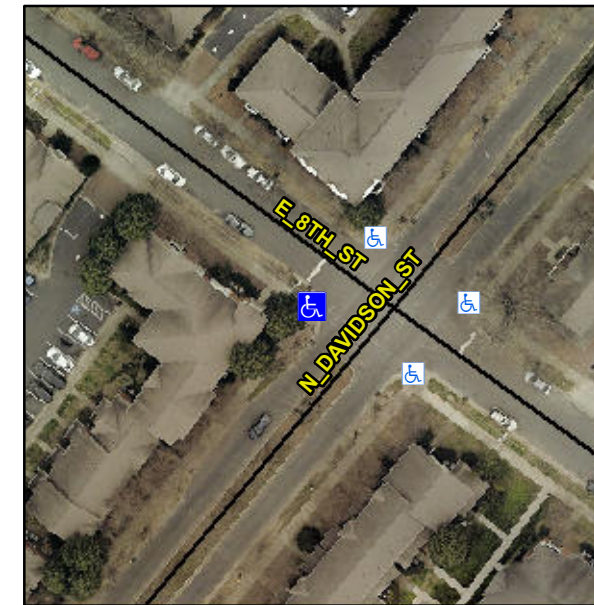
**Not Found, R304.5.1**

Compliance	Description	Data	Compliance	Description	Data
N/A	Ramp Length (in)	45.0	Yes	Ramp Slope (%)	8.1
No	Ramp Width (in)	39.0	Yes	Ramp XSlope (%)	1.3
N/A	Flare Type LT	N/A	N/A	Flare Type RT	N/A
N/A	Flare Slope LT (%)	N/A	N/A	Flare Slope RT (%)	N/A
N/A	Flare Traversable LT?	N/A	N/A	Flare Traversable RT?	N/A
N/A	Landing Length (in)	N/A	N/A	DWS Provided?	N/A
N/A	Landing Width (in)	N/A	N/A	DWS Contrast?	N/A
N/A	Landing Slope (%)	N/A	N/A	DWS Length (in)	N/A
N/A	Landing X Slope (%)	N/A	N/A	DWS Full Width?	N/A
N/A	Landing Curb? (Y/N)	N/A	N/A	DWS Offset (in)	N/A
N/A	Shared Landing?	N/A			
N/A	Gutter Ponding?	N/A	N/A	Gutter Slope (%)	N/A
N/A	Gutter Lip Ht (in)	1.0	N/A	Gutter X Slope (%)	N/A
N/A	Painted X Walk1?	No	N/A	Painted X Walk2?	No
	X Walk 1 Direction	To SE		X Walk 2 Direction	To NE
N/A	X Walk 1 Width (in)	N/A	N/A	X Walk 2 Width (in)	N/A
	X Walk 1 Slope (%)	0.8		X Walk 2 Slope (%)	2.1
	X Walk 1 X Slope (%)	1.4		X Walk 2 X Slope (%)	0.4

N/A	Ramp inside XWalk1?	N/A	N/A	Ramp inside XWalk2?	N/A
	Road Slope (%)	1.6	N/A	Clear Space?	N/A
	Road X Slope (%)	0.2	N/A	Clear Space to XWalk (in)	N/A
N/A	Any Obstructions?	N/A	N/A	Storm Grate/Utility Hazard?	N/A
	Obstruction Type			Storm Grate/Utility Type	
		N/A			N/A
			Yes	Surface Condition? (G/P)	Good

**Remove & Replace Curb Ramp With Two New Directional Ramps or Equivalent.**

Total Cost: \$ 3200.00
