# Access Compliance Report

## Public Rights-of-Way

### (Curb Ramps)

| Intersection ID: 13184 | Main Street: SUMMIT_AV | Cross Street: S_MINT_ST | Location: E |

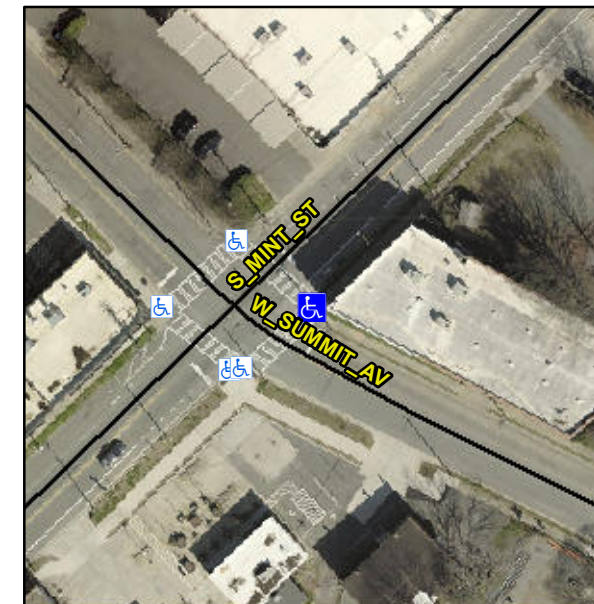
| ADA ID: D5CE7E377A8F | Ramp Type: PerpDiag | Initial Pass/Fail: Fail | Overall Compliance: No |

**Not Found, R304.2.2**

| Compliance | Description | Data | Compliance | Description | Data |
|---|---|---|---|---|---|
| N/A | Ramp Length (in) | 58.0 | No | Ramp Slope (%) | 15.7 |
| Yes | Ramp Width (in) | 48.0 | Yes | Ramp XSlope (%) | 1.8 |

**Remove & Replace Curb Ramp With Two New Directional Ramps or Equivalent.**

Total Cost: \$ 3200.00
