# Access Compliance Report

## Public Rights-of-Way

### (Curb Ramps)

Intersection ID: N/A	Main Street: DIXIE_RIVER_RD	Cross Street: GLENBURN_LN	Location: SW
ADA ID: D5D496964078	Ramp Type: Directional1	Initial Pass/Fail: Fail	Overall Compliance: No
Severity Score: 12.5			
Codes/Mitigation Info/Possible Solution		Field Measurements/Component Compliance

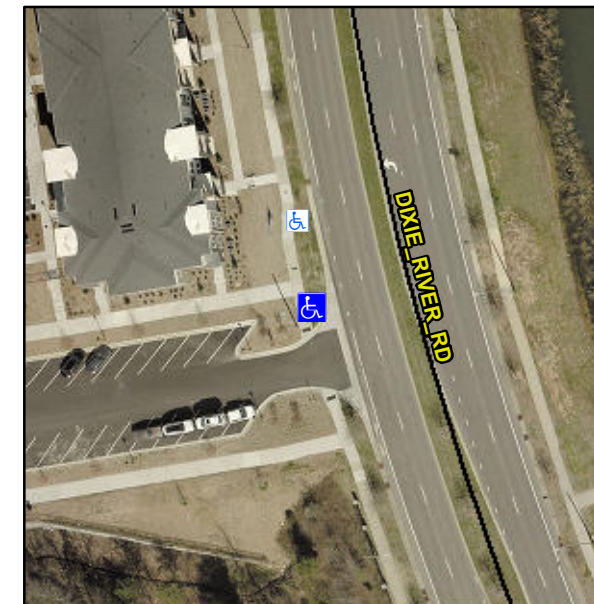
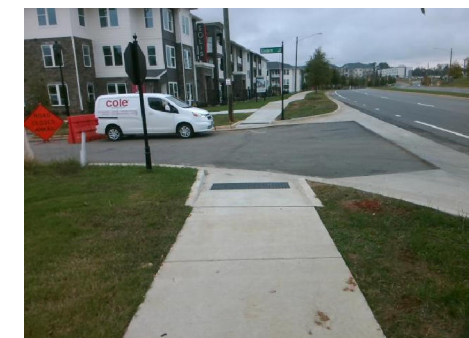
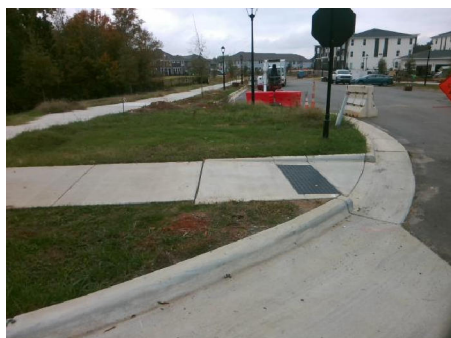
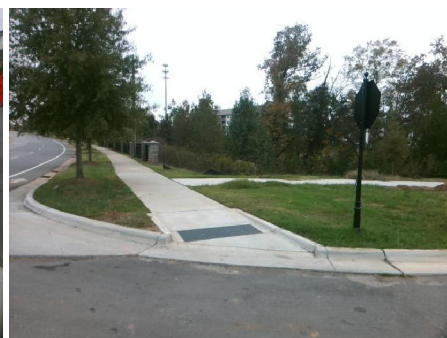
PROW/ADA:

**R304.2.2**

Compliance	Description	Data	Compliance	Description	Data
N/A	Ramp Length (in)	72.0	N/A	Grade Break?	N/A
Yes	Ramp Width (in)	71.0	N/A	Grade Break Slope (%)	0.0
No	Ramp Slope (%)	9.1	N/A	Grade Break XSlope (%)	0.0
Yes	Ramp XSlope (%)	1.9			
N/A	Flare Type LT	N/A	N/A	Flare Type RT	N/A
N/A	Flare Slope LT (%)	N/A	N/A	Flare Slope RT (%)	0.0
N/A	Flare Traversable LT?	N/A	N/A	Flare Traversable RT?	N/A
N/A	Landing Length (in)	0.0	N/A	DWS Provided?	N/A
N/A	Landing Width (in)	0.0	N/A	DWS Contrast?	N/A
N/A	Landing Slope (%)	0.0	N/A	DWS Length (in)	N/A
N/A	Landing X Slope (%)	0.0	N/A	DWS Full Width?	N/A
N/A	Landing Curb? (Y/N)	N/A	N/A	DWS Offset LT (in)	N/A
N/A	Shared Landing?	N/A	N/A	DWS Offset RT (in)	N/A
N/A	Gutter Ponding?	0.0	N/A	Gutter Slope (%)	N/A
N/A	Gutter Lip Ht (in)	0.0	N/A	Gutter X Slope (%)	N/A
N/A	Painted X Walk1?	No		Road Slope (%)	3.5
	X Walk 1 Direction	To NW		Road X Slope (%)	1.8
	X Walk 1 Width (in)	N/A		Clear Space?	N/A

X Walk 1 Slope (%)	3.5	N/A	Clear Space to XWalk (in)	N/A
	X Walk 1 X Slope (%)	1.8	N/A	Storm Grate/Utility Hazard?	N/A
N/A	Ramp inside XWalk1?	N/A		Storm Grate/Utility Type	
N/A	Any Obstructions?	N/A			N/A
	Obstruction Type		Yes	Surface Condition? (G/P)	Good
			N/A	Curb Slope (%)	16.1

Possible Solutions:

**Remove & Replace Entire Ramp.**
