Access Compliance Report

Public Rights-of-Way

(Curb Ramps)

Intersection ID: 48492	Main Street: SHOPTON_RD_WEST	Cross Street: BEREWICK_COMMONS_PY	Location: SE
ADA ID: D5D530384AC5	Ramp Type: Perp	Initial Pass/Fail: Fail	Overall Compliance: No
Severity Score: 13.75			
Codes/Mitigation Info/Possible Solution		Field Measurements/Component Compliance

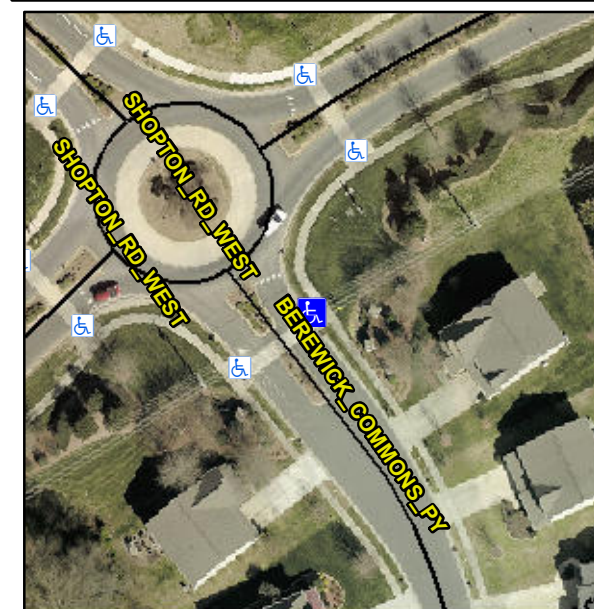
Not Found, R304.2.2, R304.5.3

Compliance	Description	Data	Compliance	Description	Data
N/A	Ramp Length (in)	57.0	No	Ramp Slope (%)	8.8
Yes	Ramp Width (in)	48.0	No	Ramp XSlope (%)	3.0
N/A	Flare Type LT	N/A	N/A	Flare Type RT	N/A
N/A	Flare Slope LT (%)	N/A	N/A	Flare Slope RT (%)	N/A
N/A	Flare Traversable LT?	N/A	N/A	Flare Traversable RT?	N/A
N/A	Landing Length (in)	N/A	N/A	DWS Provided?	N/A
N/A	Landing Width (in)	N/A	N/A	DWS Contrast?	N/A
N/A	Landing Slope (%)	N/A	N/A	DWS Length (in)	N/A
N/A	Landing X Slope (%)	N/A	N/A	DWS Full Width?	N/A
N/A	Landing Curb? (Y/N)	N/A	N/A	DWS Offset (in)	N/A
N/A	Shared Landing?	N/A			
N/A	Gutter Ponding?	N/A	N/A	Gutter Slope (%)	N/A
N/A	Gutter Lip Ht (in)	N/A	N/A	Gutter X Slope (%)	N/A
N/A	Painted X Walk1?	Yes	N/A	Painted X Walk2?	N/A
	X Walk 1 Direction	To SW		X Walk 2 Direction	N/A
N/A	X Walk 1 Width (in)	96.0	N/A	X Walk 2 Width (in)	N/A
	X Walk 1 Slope (%)	1.8		X Walk 2 Slope (%)	N/A
	X Walk 1 X Slope (%)	2.6		X Walk 2 X Slope (%)	N/A

N/A	Ramp inside XWalk1?	Yes	N/A	Ramp inside XWalk2?	N/A
	Road Slope (%)	N/A	N/A	Clear Space?	N/A
	Road X Slope (%)	N/A	N/A	Clear Space to XWalk (in)	N/A
N/A	Any Obstructions?	N/A	N/A	Storm Grate/Utility Hazard?	N/A
	Obstruction Type			Storm Grate/Utility Type	
		N/A			N/A
			Yes	Surface Condition? (G/P)	Good

Possible Solutions:

Remove & Replace Entire Ramp.
