Access Compliance Report

Public Rights-of-Way

(Curb Ramps)

Intersection ID: 5784	Main Street: FOSTER_BROOK_DR	Cross Street: OAKDALE_GREEN_DR	Location: W
ADA ID: D5D8F10C72C0	Ramp Type: PerpDiag	Initial Pass/Fail: Fail	Overall Compliance: No
Severity Score: 10			
Codes/Mitigation Info/Possible Solution		Field Measurements/Component Compliance

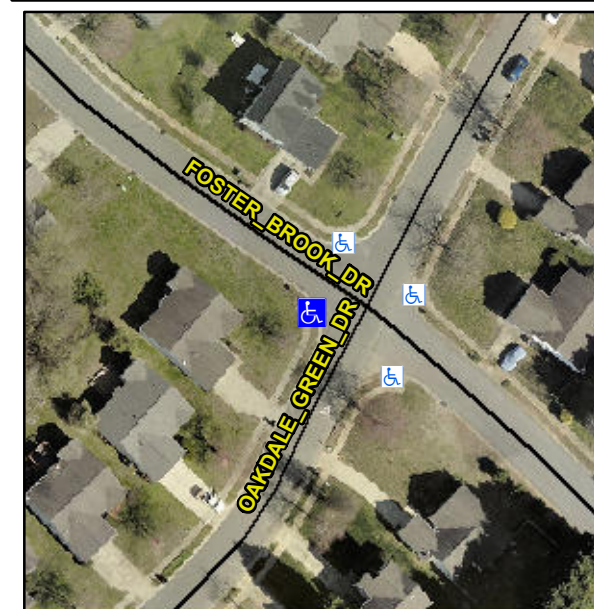
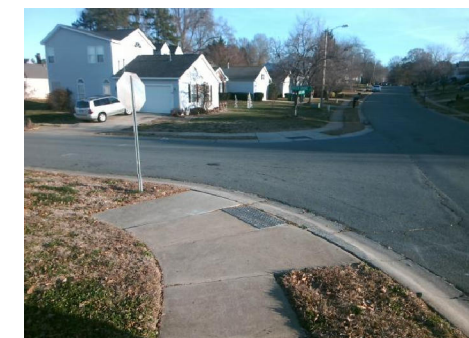
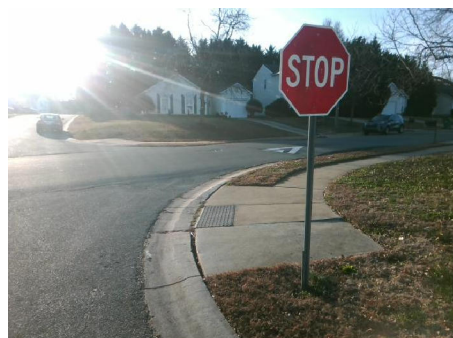
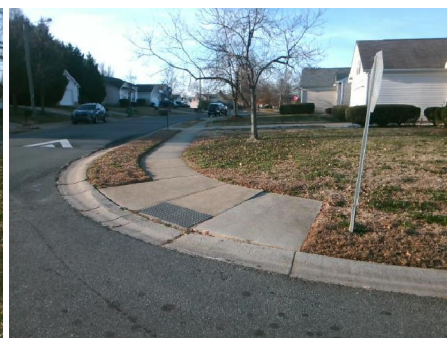
Not Found, R304.5.1, R304.5.3

Compliance	Description	Data	Compliance	Description	Data
N/A	Ramp Length (in)	96.0	Yes	Ramp Slope (%)	6.8
No	Ramp Width (in)	38.0	No	Ramp XSlope (%)	2.8
N/A	Flare Type LT	N/A	N/A	Flare Type RT	N/A
N/A	Flare Slope LT (%)	N/A	N/A	Flare Slope RT (%)	N/A
N/A	Flare Traversable LT?	N/A	N/A	Flare Traversable RT?	N/A
N/A	Landing Length (in)	N/A	N/A	DWS Provided?	N/A
N/A	Landing Width (in)	N/A	N/A	DWS Contrast?	N/A
N/A	Landing Slope (%)	N/A	N/A	DWS Length (in)	N/A
N/A	Landing X Slope (%)	N/A	N/A	DWS Full Width?	N/A
N/A	Landing Curb? (Y/N)	N/A	N/A	DWS Offset (in)	N/A
N/A	Shared Landing?	N/A			
N/A	Gutter Ponding?	N/A	N/A	Gutter Slope (%)	N/A
N/A	Gutter Lip Ht (in)	N/A	N/A	Gutter X Slope (%)	N/A
N/A	Painted X Walk1?	No	N/A	Painted X Walk2?	No
	X Walk 1 Direction	To SE		X Walk 2 Direction	To NE
N/A	X Walk 1 Width (in)	N/A	N/A	X Walk 2 Width (in)	N/A
	X Walk 1 Slope (%)	3.8		X Walk 2 Slope (%)	2.3
	X Walk 1 X Slope (%)	1.1		X Walk 2 X Slope (%)	4.1

N/A	Ramp inside XWalk1?	N/A	N/A	Ramp inside XWalk2?	N/A
	Road Slope (%)	3.2	N/A	Clear Space?	N/A
	Road X Slope (%)	3.6	N/A	Clear Space to XWalk (in)	N/A
N/A	Any Obstructions?	N/A	N/A	Storm Grate/Utility Hazard?	N/A
	Obstruction Type			Storm Grate/Utility Type	
		N/A			N/A
			Yes	Surface Condition? (G/P)	Good

Remove & Replace Curb Ramp With Two New Directional Ramps or Equivalent.
