Intersection ID: 13522	Main Street: MCCLINTOCK_RD	Cross Street: WESTOVER_ST	Location:	NE
ADA ID: D5D9A74C26BD	Ramp Type: PerpDiag	Initial Pass/Fail: Fail	Overall Compliance: No	Severity Score: 21.25

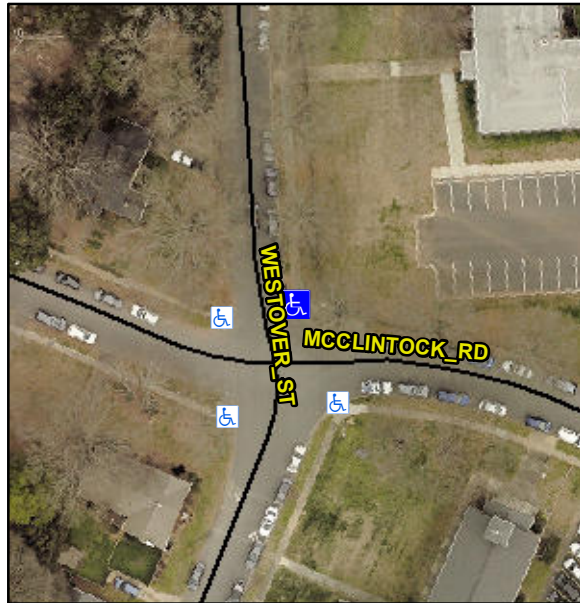
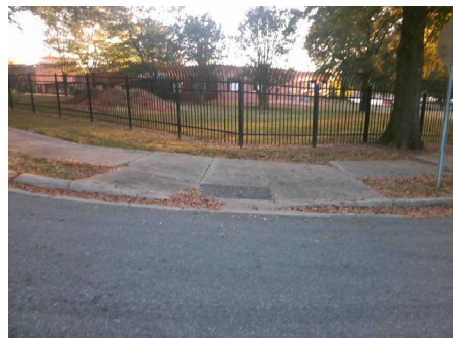
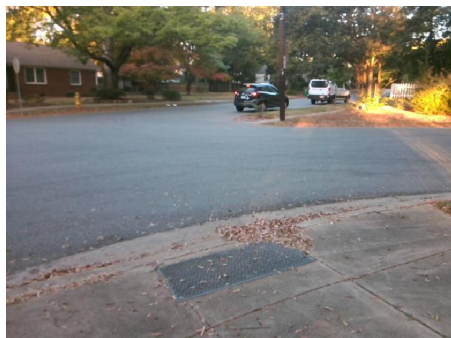
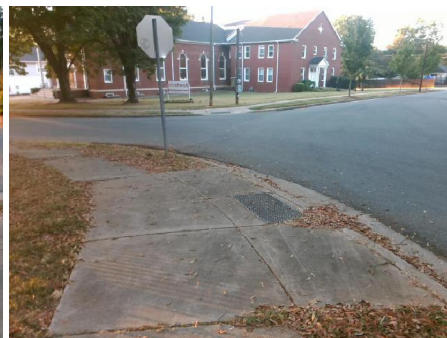
Not Found, R304.5.1, R304.5.3

Compliance	Description	Data	Compliance	Description	Data
N/A	Ramp Length (in)	43.0	Yes	Ramp Slope (%)	6.5
No	Ramp Width (in)	44.5	No	Ramp XSlope (%)	5.5
N/A	Flare Type LT	N/A	N/A	Flare Type RT	N/A
N/A	Flare Slope LT (%)	N/A	N/A	Flare Slope RT (%)	N/A
N/A	Flare Traversable LT?	N/A	N/A	Flare Traversable RT?	N/A
N/A	Landing Length (in)	N/A	N/A	DWS Provided?	N/A
N/A	Landing Width (in)	N/A	N/A	DWS Contrast?	N/A
N/A	Landing Slope (%)	N/A	N/A	DWS Length (in)	N/A
N/A	Landing X Slope (%)	N/A	N/A	DWS Full Width?	N/A
N/A	Landing Curb? (Y/N)	N/A	N/A	DWS Offset (in)	N/A
N/A	Shared Landing?	N/A			
N/A	Gutter Ponding?	N/A	N/A	Gutter Slope (%)	N/A
N/A	Gutter Lip Ht (in)	N/A	N/A	Gutter X Slope (%)	N/A
N/A	Painted X Walk1?	No	N/A	Painted X Walk2?	No
	X Walk 1 Direction	To W		X Walk 2 Direction	To S
N/A	X Walk 1 Width (in)	N/A	N/A	X Walk 2 Width (in)	N/A
	X Walk 1 Slope (%)	7.1		X Walk 2 Slope (%)	2.0
	X Walk 1 X Slope (%)	2.1		X Walk 2 X Slope (%)	7.0

N/A	Ramp inside XWalk1?	N/A	N/A	Ramp inside XWalk2?	N/A
	Road Slope (%)	5.9	N/A	Clear Space?	N/A
	Road X Slope (%)	6.5	N/A	Clear Space to XWalk (in)	N/A
N/A	Any Obstructions?	N/A	N/A	Storm Grate/Utility Hazard?	N/A
	Obstruction Type			Storm Grate/Utility Type	
		N/A			N/A
			Yes	Surface Condition? (G/P)	Good

Remove & Replace Curb Ramp With Two New Directional Ramps or Equivalent.
