Access Compliance Report

Public Rights-of-Way

(Curb Ramps)

Intersection ID: 13502	Main Street: WEST_BV	Cross Street: WILMORE_DR	Location: NE
ADA ID: D5E54883A406	Ramp Type: PerpDiag	Initial Pass/Fail: Fail	Overall Compliance: No
Codes/Mitigation Info/Possible Solution		Field Measurements/Component Compliance

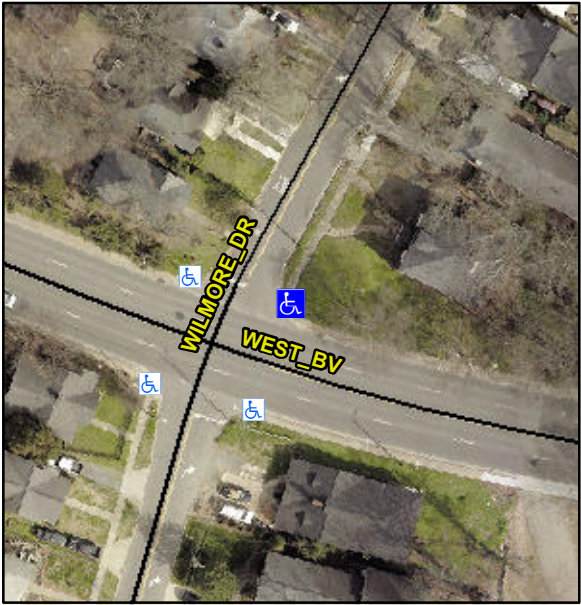
N/A	Shared Landing?	N/A			
		N/A	Gutter Ponding?	N/A	N/A	Gutter Slope (%)	N/A
		N/A	Gutter Lip Ht (in)	N/A	N/A	Gutter X Slope (%)	N/A
		N/A	Painted X Walk1?	No	N/A	Painted X Walk2?	No
			X Walk 1 Direction	To NW		X Walk 2 Direction	To SW
		N/A	X Walk 1 Width (in)	N/A	N/A	X Walk 2 Width (in)	N/A
			X Walk 1 Slope (%)	4.1		X Walk 2 Slope (%)	11.7
			X Walk 1 X Slope (%)	7.2		X Walk 2 X Slope (%)	5.0
		N/A	Ramp inside XWalk1?	N/A	N/A	Ramp inside XWalk2?	N/A
			Road Slope (%)	8.8	N/A	Clear Space?	N/A
			Road X Slope (%)	4.1	N/A	Clear Space to XWalk (in)	N/A
		N/A	Any Obstructions?	N/A	N/A	Storm Grate/Utility Hazard?	N/A
			Obstruction Type			Storm Grate/Utility Type	
				N/A			N/A
					Yes	Surface Condition? (G/P)	Good

Possible Solutions:						
	Remove & Replace Curb Ramp With Two New Directional Ramps or Equivalent.	Compliance	Description	Data	Compliance	Description	Data
<p>Surveyor Notes:</p> <p>N/A</p>	<p>PROW/ADA:</p> <p>Not Found, R304.5.1, R304.2.2, R304.5.3</p>	N/A	Ramp Length (in)	59.0	No	Ramp Slope (%)	10.1
		No	Ramp Width (in)	41.0	No	Ramp XSlope (%)	10.0
<p>Street 1 Name</p> <p>Stop Condition-Street 2</p> <p>Street 2 Name</p> <p>Stop Condition-Street 1</p>	<p>WILMORE DR</p> <p>StopSign</p> <p>WEST BV</p> <p>None</p>	N/A	Flare Type LT	N/A	N/A	Flare Type RT	N/A
		N/A	Flare Slope LT (%)	N/A	N/A	Flare Slope RT (%)	N/A
		N/A	Flare Traversable LT?	N/A	N/A	Flare Traversable RT?	N/A
		N/A	Landing Length (in)	N/A	N/A	DWS Provided?	N/A
		N/A	Landing Width (in)	N/A	N/A	DWS Contrast?	N/A
		N/A	Landing Slope (%)	N/A	N/A	DWS Length (in)	N/A
		N/A	Landing X Slope (%)	N/A	N/A	DWS Full Width?	N/A
		N/A	Landing Curb? (Y/N)	N/A	N/A	DWS Offset (in)	N/A
