# Access Compliance Report

## Public Rights-of-Way

### (Curb Ramps)

| Intersection ID: 8157 | Main Street: N_TRYON_ST | Cross Street: ORR_RD | Location: SE |

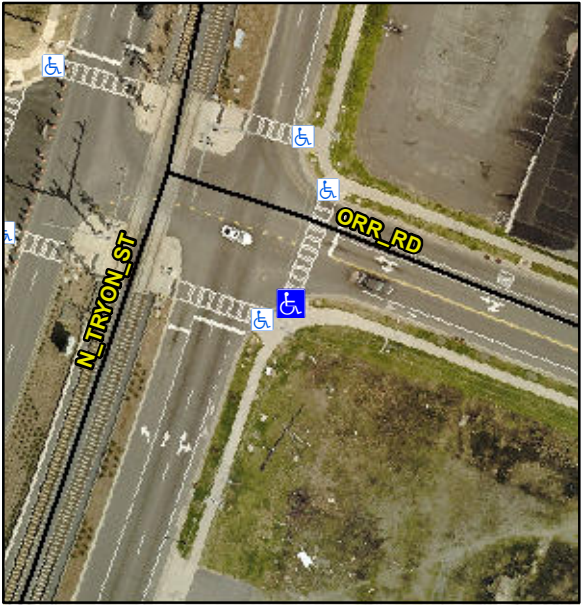
| ADA ID: D5F5FE3CBBAC | Ramp Type: Perp | Initial Pass/Fail: Fail | Overall Compliance: No |

| Codes/Mitigation Info/Possible Solution | | | Field Measurements/Component Compliance | | | |
|---|---|--|---|---|---|---|
| | | | <b>No</b> | Ramp Width (in) | <b>47.0</b> | |
| <p>Surveyor Notes:</p> <p><b>N/A</b></p> <p>PROW/ADA:</p> <p><b>R304.5.1, R304.5.3</b></p> | | | <b>N/A</b> | Flare Type RT | <b>N/A</b> | |

| Codes/Mitigation Info/Possible Solution | | | Field Measurements/Component Compliance | | | |
|---|---|--|---|---|---|---|
| | <b>Remove &amp; Replace Entire Ramp.</b> | | <b>Yes</b> | Ramp Slope (%) | <b>5.4</b> | |
