# Access Compliance Report

## Public Rights-of-Way

### (Curb Ramps)

Intersection ID: 7812	Main Street: SQUIRREL_HILL_RD	Cross Street: THORNWOOD_RD	Location: S
ADA ID: D5FAFBCB448D	Ramp Type: Perp	Initial Pass/Fail: Fail	Overall Compliance: No
Severity Score: 10			
Codes/Mitigation Info/Possible Solution		Field Measurements/Component Compliance

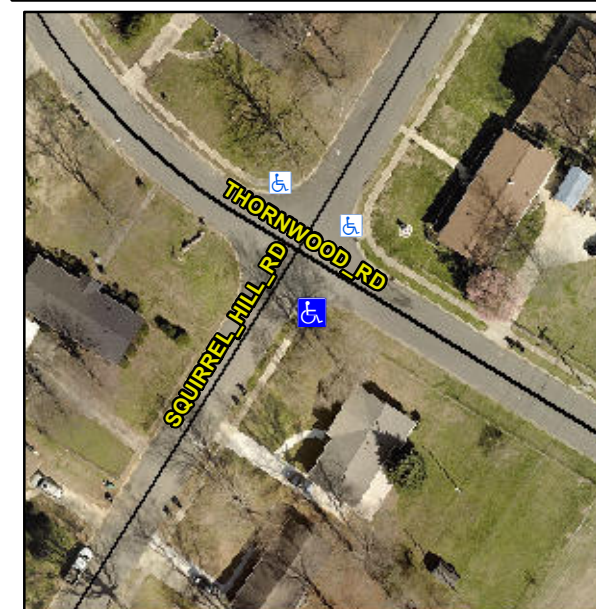
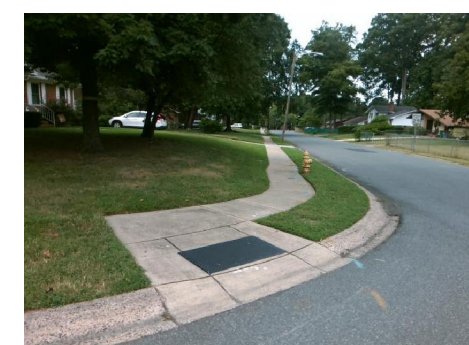
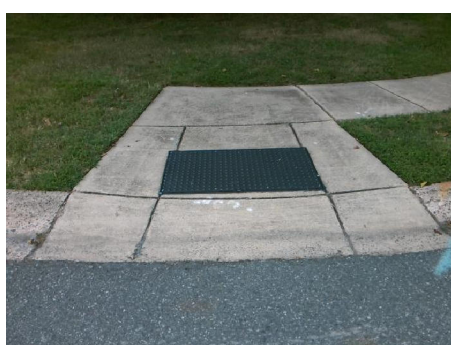
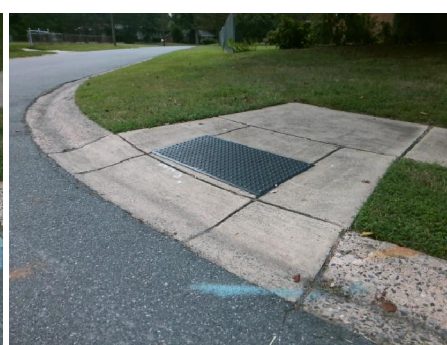
**Not Found, R304.5.1, R304.5.3**

Compliance	Description	Data	Compliance	Description	Data
N/A	Ramp Length (in)	47.5	Yes	Ramp Slope (%)	5.7
No	Ramp Width (in)	41.0	No	Ramp XSlope (%)	2.5
N/A	Flare Type LT	N/A	N/A	Flare Type RT	N/A
N/A	Flare Slope LT (%)	N/A	N/A	Flare Slope RT (%)	N/A
N/A	Flare Traversable LT?	N/A	N/A	Flare Traversable RT?	N/A
N/A	Landing Length (in)	N/A	N/A	DWS Provided?	N/A
N/A	Landing Width (in)	N/A	N/A	DWS Contrast?	N/A
N/A	Landing Slope (%)	N/A	N/A	DWS Length (in)	N/A
N/A	Landing X Slope (%)	N/A	N/A	DWS Full Width?	N/A
N/A	Landing Curb? (Y/N)	N/A	N/A	DWS Offset (in)	N/A
N/A	Shared Landing?	N/A			
N/A	Gutter Ponding?	N/A	N/A	Gutter Slope (%)	N/A
N/A	Gutter Lip Ht (in)	1.0	N/A	Gutter X Slope (%)	N/A
N/A	Painted X Walk1?	No	N/A	Painted X Walk2?	N/A
	X Walk 1 Direction	To NE		X Walk 2 Direction	N/A
N/A	X Walk 1 Width (in)	N/A	N/A	X Walk 2 Width (in)	N/A
	X Walk 1 Slope (%)	4.6		X Walk 2 Slope (%)	N/A
	X Walk 1 X Slope (%)	0.2		X Walk 2 X Slope (%)	N/A

N/A	Ramp inside XWalk1?	N/A	N/A	Ramp inside XWalk2?	N/A
	Road Slope (%)	N/A	N/A	Clear Space?	N/A
	Road X Slope (%)	N/A	N/A	Clear Space to XWalk (in)	N/A
N/A	Any Obstructions?	N/A	N/A	Storm Grate/Utility Hazard?	N/A
	Obstruction Type			Storm Grate/Utility Type	
		N/A			N/A
			Yes	Surface Condition? (G/P)	Good

**Remove & Replace Entire Ramp.**

Total Cost: \$ 1850.00
