Access Compliance Report

Public Rights-of-Way

(Curb Ramps)

Intersection ID: 31209	Main Street: CAPRINGTON_AV	Cross Street: CLACKWYCK_LN	Location: S
ADA ID: D5FCB7E69F57	Ramp Type: PerpDiag	Initial Pass/Fail: Fail	Overall Compliance: No
		Severity Score: 25

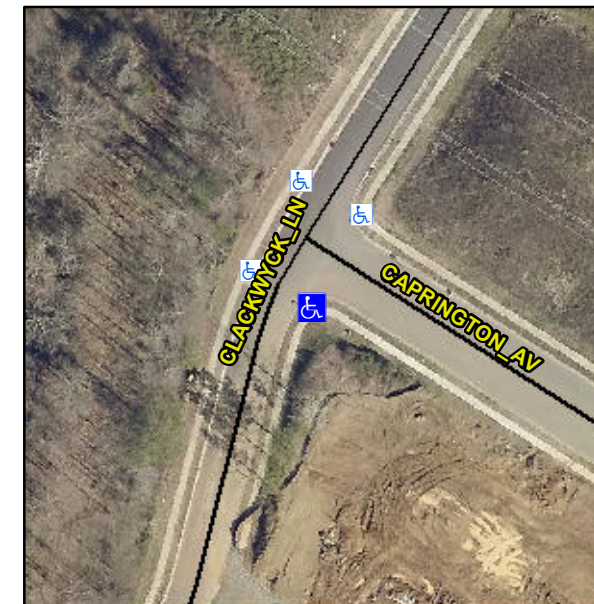
Compliance	Description	Data	Compliance	Description	Data
N/A	Ramp Length (in)	38.0	Yes	Ramp Slope (%)	5.1
Yes	Ramp Width (in)	48.0	No	Ramp XSlope (%)	9.7
N/A	Flare Type LT	N/A	N/A	Flare Type RT	N/A
N/A	Flare Slope LT (%)	N/A	N/A	Flare Slope RT (%)	N/A
N/A	Flare Traversable LT?	N/A	N/A	Flare Traversable RT?	N/A
N/A	Landing Length (in)	N/A	N/A	DWS Provided?	N/A
N/A	Landing Width (in)	N/A	N/A	DWS Contrast?	N/A
N/A	Landing Slope (%)	N/A	N/A	DWS Length (in)	N/A
N/A	Landing X Slope (%)	N/A	N/A	DWS Full Width?	N/A
N/A	Landing Curb? (Y/N)	N/A	N/A	DWS Offset (in)	N/A
N/A	Shared Landing?	N/A			
N/A	Gutter Ponding?	N/A	N/A	Gutter Slope (%)	N/A
N/A	Gutter Lip Ht (in)	N/A	N/A	Gutter X Slope (%)	N/A
N/A	Painted X Walk1?	No	N/A	Painted X Walk2?	No
	X Walk 1 Direction	To NE		X Walk 2 Direction	To NW
N/A	X Walk 1 Width (in)	N/A	N/A	X Walk 2 Width (in)	N/A
	X Walk 1 Slope (%)	5.4		X Walk 2 Slope (%)	3.9
	X Walk 1 X Slope (%)	10.5		X Walk 2 X Slope (%)	8.9

N/A	Ramp inside XWalk1?	N/A	N/A	Ramp inside XWalk2?	N/A
	Road Slope (%)	11.0	N/A	Clear Space?	N/A
	Road X Slope (%)	7.2	N/A	Clear Space to XWalk (in)	N/A
N/A	Any Obstructions?	N/A	N/A	Storm Grate/Utility Hazard?	N/A
	Obstruction Type			Storm Grate/Utility Type	
		N/A			N/A
			Yes	Surface Condition? (G/P)	Good

Remove & Replace Curb Ramp With Two New Directional Ramps or Equivalent.
