# Access Compliance Report

## Public Rights-of-Way

### (Curb Ramps)

Intersection ID: 50193	Main Street: CHARNDON_VILLAGE_CT	Cross Street: BOYCE_RD	Location: NW
ADA ID: D605305B0593	Ramp Type: Directional1	Initial Pass/Fail: Fail	Overall Compliance: No
Severity Score: 12.5			
Codes/Mitigation Info/Possible Solution		Field Measurements/Component Compliance

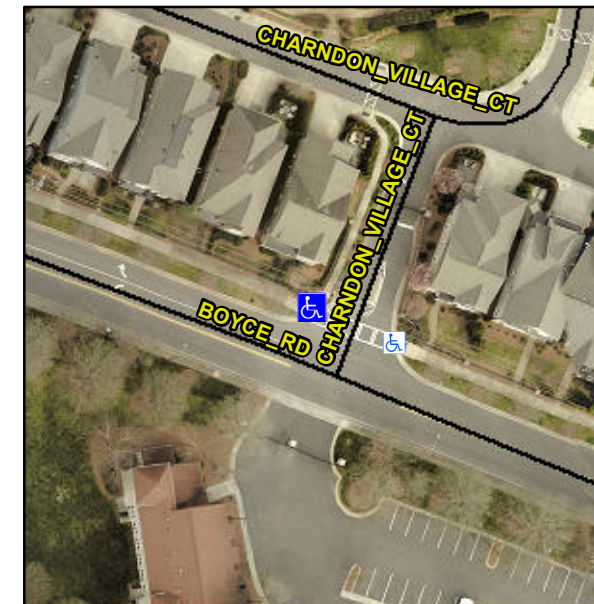
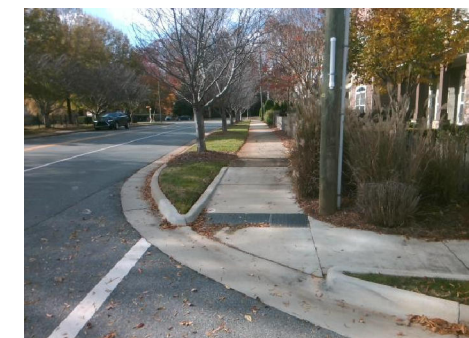
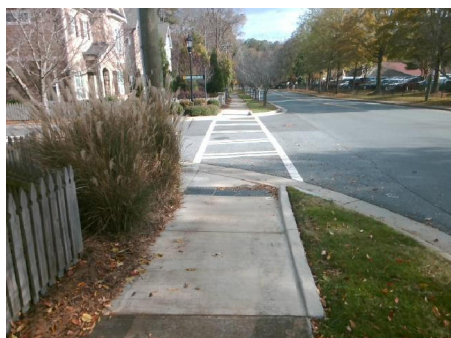
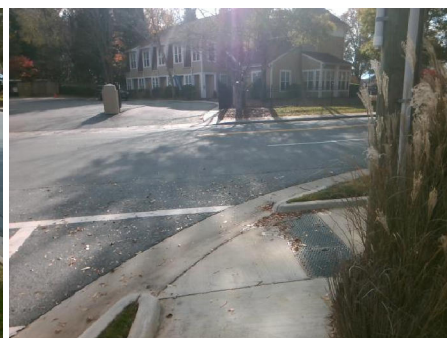
Compliance	Description	Data	Compliance	Description	Data
N/A	Ramp Length (in)	169.0	N/A	Grade Break?	N/A
Yes	Ramp Width (in)	68.0	N/A	Grade Break Slope (%)	0.0
No	Ramp Slope (%)	8.6	N/A	Grade Break XSlope (%)	0.0
Yes	Ramp XSlope (%)	0.0			
N/A	Flare Type LT	N/A	N/A	Flare Type RT	N/A
N/A	Flare Slope LT (%)	N/A	N/A	Flare Slope RT (%)	0.0
N/A	Flare Traversable LT?	N/A	N/A	Flare Traversable RT?	N/A
N/A	Landing Length (in)	0.0	N/A	DWS Provided?	N/A
N/A	Landing Width (in)	0.0	N/A	DWS Contrast?	N/A
N/A	Landing Slope (%)	0.0	N/A	DWS Length (in)	N/A
N/A	Landing X Slope (%)	0.0	N/A	DWS Full Width?	N/A
N/A	Landing Curb? (Y/N)	N/A	N/A	DWS Offset LT (in)	N/A
N/A	Shared Landing?	N/A	N/A	DWS Offset RT (in)	N/A
N/A	Gutter Ponding?	0.0	N/A	Gutter Slope (%)	N/A
N/A	Gutter Lip Ht (in)	0.0	N/A	Gutter X Slope (%)	N/A
N/A	Painted X Walk1?	Yes		Road Slope (%)	1.7
	X Walk 1 Direction	To E		Road X Slope (%)	3.6
	X Walk 1 Width (in)	89.0		Clear Space?	N/A

X Walk 1 Slope (%)	1.7	N/A	Clear Space to XWalk (in)	N/A
	X Walk 1 X Slope (%)	3.6	N/A	Storm Grate/Utility Hazard?	N/A
N/A	Ramp inside XWalk1?	Yes		Storm Grate/Utility Type	
N/A	Any Obstructions?	N/A			N/A
	Obstruction Type		Yes	Surface Condition? (G/P)	Good
			N/A	Curb Slope (%)	5.4

Possible Solutions:

**Remove & Replace Entire Ramp.**

PROW/ADA:

**R304.2.2**
