Access Compliance Report

Public Rights-of-Way

(Curb Ramps)

Intersection ID: 2827	Main Street: DERVISH_LN	Cross Street: SWALLOW_TAIL_LN	Location: W
ADA ID: D60BC09E6F4B	Ramp Type: BlendTrans1	Initial Pass/Fail: Fail	Overall Compliance: No
			Severity Score: 33.75

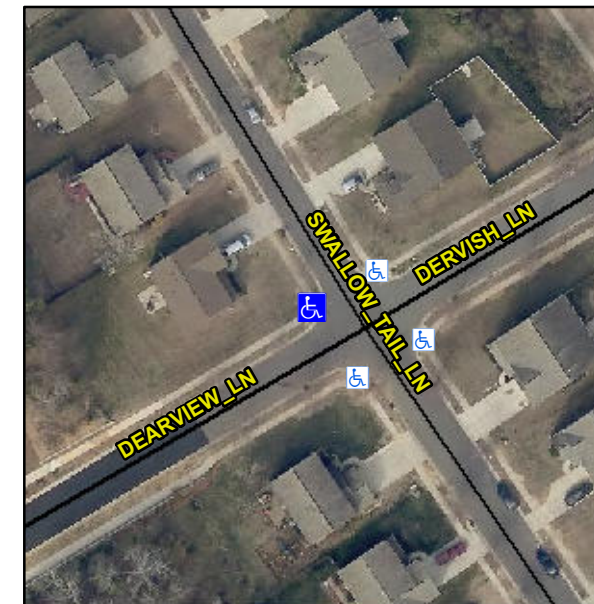
Not Found, R304.5.1, R304.5.3

Compliance	Description	Data	Compliance	Description	Data
N/A	Ramp Length (in)	47.0	Yes	BlendTrans Slope (%)	3.6
No	Ramp Width (in)	39.0	No	BlendTrans XSlope (%)	10.2
N/A	Flare Type LT	N/A	N/A	Flare Type RT	N/A
N/A	Flare Slope LT (%)	N/A	N/A	Flare Slope RT (%)	N/A
N/A	Flare Traversable LT?	N/A	N/A	Flare Traversable RT?	N/A
N/A	Landing Length (in)	N/A	N/A	DWS Provided?	N/A
N/A	Landing Width (in)	N/A	N/A	DWS Contrast?	N/A
N/A	Landing Slope (%)	N/A	N/A	DWS Length (in)	N/A
N/A	Landing X Slope (%)	N/A	N/A	DWS Full Width?	N/A
N/A	Landing Curb? (Y/N)	N/A	N/A	DWS Offset (in)	N/A
N/A	Shared Landing?	N/A			
N/A	Gutter Ponding?	N/A	N/A	Gutter Slope (%)	N/A
N/A	Gutter Lip Ht (in)	N/A	N/A	Gutter X Slope (%)	N/A
N/A	Painted X Walk1?	No	N/A	Painted X Walk2?	No
	X Walk 1 Direction	To SE		X Walk 2 Direction	To NE
	X Walk 1 Width (in)	N/A		X Walk 2 Width (in)	N/A
	X Walk 1 Slope (%)	5.2		X Walk 2 Slope (%)	3.6
	X Walk 1 X Slope (%)	6.5		X Walk 2 X Slope (%)	6.2

N/A	Ramp inside XWalk1?	N/A	N/A	Ramp inside XWalk2?	N/A
	Road Slope (%)	7.4		Clear Space?	N/A
	Road X Slope (%)	3.1	N/A	Clear Space to XWalk (in)	N/A
N/A	Any Obstructions?	N/A	N/A	Storm Grate/Utility Hazard?	N/A
	Obstruction Type			Storm Grate/Utility Type	
		N/A			N/A
			Yes	Surface Condition? (G/P)	Good
			No	Curb Slope (%)	16.9

Possible Solutions:

Remove & Replace Curb Ramp With Two New Directional Ramps or Equivalent.
