Access Compliance Report

Public Rights-of-Way

(Curb Ramps)

Intersection ID: 16313	Main Street: BILLINGSLEY_RD	Cross Street: JONQUIL_ST	Location: NE
ADA ID: D60D55D7A49F	Ramp Type: PerpDiag	Initial Pass/Fail: Fail	Overall Compliance: No
Codes/Mitigation Info/Possible Solution		Field Measurements/Component Compliance	
Severity Score: 33.75

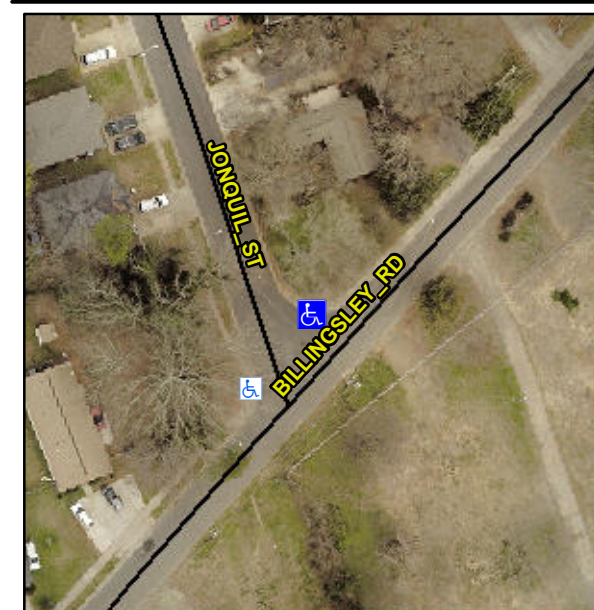
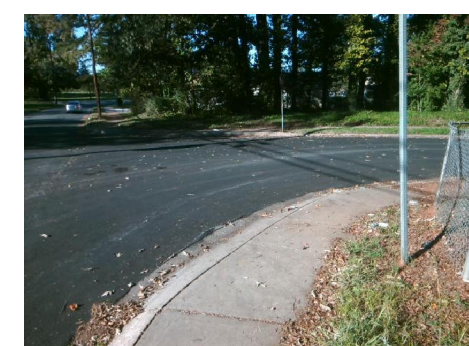
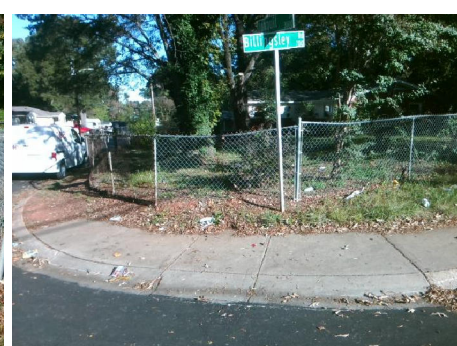
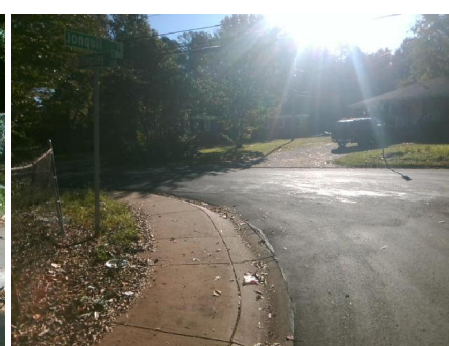
Not Found, R304.5.1, R304.2.2, R304.5.3

Compliance	Description	Data	Compliance	Description	Data
N/A	Ramp Length (in)	55.0	No	Ramp Slope (%)	8.9
No	Ramp Width (in)	42.0	No	Ramp XSlope (%)	6.0
N/A	Flare Type LT	N/A	N/A	Flare Type RT	N/A
N/A	Flare Slope LT (%)	N/A	N/A	Flare Slope RT (%)	N/A
N/A	Flare Traversable LT?	N/A	N/A	Flare Traversable RT?	N/A
N/A	Landing Length (in)	N/A	N/A	DWS Provided?	N/A
N/A	Landing Width (in)	N/A	N/A	DWS Contrast?	N/A
N/A	Landing Slope (%)	N/A	N/A	DWS Length (in)	N/A
N/A	Landing X Slope (%)	N/A	N/A	DWS Full Width?	N/A
N/A	Landing Curb? (Y/N)	N/A	N/A	DWS Offset (in)	N/A
N/A	Shared Landing?	N/A			
N/A	Gutter Ponding?	N/A	N/A	Gutter Slope (%)	N/A
N/A	Gutter Lip Ht (in)	N/A	N/A	Gutter X Slope (%)	N/A
N/A	Painted X Walk1?	No	N/A	Painted X Walk2?	No
	X Walk 1 Direction	To SW		X Walk 2 Direction	To SE
N/A	X Walk 1 Width (in)	N/A	N/A	X Walk 2 Width (in)	N/A
	X Walk 1 Slope (%)	0.2		X Walk 2 Slope (%)	7.6
	X Walk 1 X Slope (%)	5.3		X Walk 2 X Slope (%)	0.0

N/A	Ramp inside XWalk1?	N/A	N/A	Ramp inside XWalk2?	N/A
	Road Slope (%)	5.5	N/A	Clear Space?	N/A
	Road X Slope (%)	4.5	N/A	Clear Space to XWalk (in)	N/A
N/A	Any Obstructions?	N/A	N/A	Storm Grate/Utility Hazard?	N/A
	Obstruction Type			Storm Grate/Utility Type	
		N/A			N/A
			Yes	Surface Condition? (G/P)	Good

Remove & Replace Curb Ramp With Two New Directional Ramps or Equivalent.
