Access Compliance Report Public Rights-of-Way (Curb Ramps)

Intersection ID: 28611 Main Street: FALCONCREST_DR Cross Street: KESTRAL_RIDGE_DR Location: W

ADA ID: D6198E9FD3EE Ramp Type: BlendTrans1 Initial Pass/Fail: Fail Overall Compliance: No Severity Score: 8.75

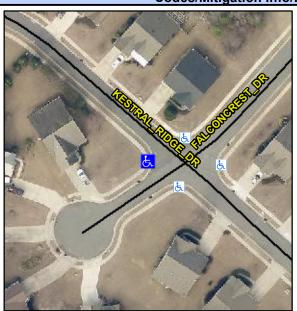
PROW/ADA:
Not Found, R304.5.1

Compliance Description Data Compliance Description Data Yes BlendTrans Slope (%) N/A Ramp Length (in) 46.0 3.7 Yes No Ramp Width (in) 43.0 BlendTrans XSlope (%) 1.5 N/A N/A Flare Type LT N/A Flare Type RT N/A N/A Flare Slope LT (%) N/A N/A Flare Slope RT (%) N/A N/A Flare Traversable LT? N/A N/A Flare Traversable RT? N/A N/A Landing Length (in) N/A N/A **DWS Provided?** N/A N/A Landing Width (in) N/A N/A **DWS Contrast?** N/A N/A N/A N/A Landing Slope (%) DWS Length (in) N/A N/A Landing X Slope (%) N/A N/A DWS Full Width? N/A N/A Landing Curb? (Y/N) N/A N/A DWS Offset (in) N/A N/A N/A Shared Landing? N/A **Gutter Ponding?** N/A N/A Gutter Slope (%) N/A N/A Gutter Lip Ht (in) N/A N/A Gutter X Slope (%) N/A N/A Painted X Walk1? No N/A Painted X Walk2? No X Walk 1 Direction To NE X Walk 2 Direction To SE N/A N/A X Walk 1 Width (in) X Walk 2 Width (in) X Walk 1 Slope (%) 0.7 X Walk 2 Slope (%) 2.4 X Walk 1 X Slope (%) 3.5 X Walk 2 X Slope (%) 1.6 N/A N/A Ramp inside XWalk2? N/A N/A Ramp inside XWalk1? Road Slope (%) 4.1 Clear Space? N/A Road X Slope (%) N/A Clear Space to XWalk (in) N/A 1.3 N/A N/A N/A Any Obstructions? Storm Grate/Utility Hazard? N/A

Remove & Replace Curb Ramp With
Two New Directional Ramps or
Equivalent.

Total Cost: \$ 3200.00
