Intersection ID: 24614 Main Street: BECKMORE_PL Cross Street: PINEVILLE-MATTHEWS_RD Location: NW

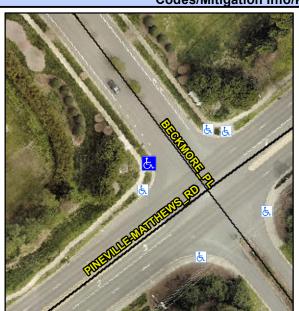
Total Cost: \$ 2600.00

Field Measurements/Component Compliance						
Compliance Description		Data	Comp	liance Description	Data	
N/A	Ramp Length (in)	96.0	Yes	Ramp Slope (%)	5.5	
Yes	Ramp Width (in)	60.0	Yes	Ramp XSlope (%)	0.5	
N/A	Flare Type LT	Sloped	N/A	Flare Type RT	N/A	
N/A	Flare Slope LT (%)	10.5	Yes	Flare Slope RT (%)	9.3	
N/A	Flare Traversable LT?	Yes	N/A	Flare Traversable RT?	Yes	
Yes	Landing Length (in)	58.0	No	DWS Provided?	No	
Yes	Landing Width (in)	60.0	N/A	DWS Contrast?	No	
Yes	Landing Slope (%)	0.9	N/A	DWS Length (in)	N/A	
Yes	Landing X Slope (%)	1.5	N/A	DWS Full Width?	No	
N/A	Landing Curb? (Y/N)	No	N/A	DWS Offset (in)	N/A	
N/A	Shared Landing?	No				
Yes	Gutter Ponding?	No	No	Gutter Slope (%)	5.7	
Yes	Gutter Lip Ht (in)	0.0	No	Gutter X Slope (%)	2.9	
N/A	Painted X Walk1?	No	N/A	Painted X Walk2?	N/A	
	X Walk 1 Direction	To E		X Walk 2 Direction	N/A	
N/A	X Walk 1 Width (in)	N/A	N/A	X Walk 2 Width (in)	N/A	
	X Walk 1 Slope (%)	2.5		X Walk 2 Slope (%)	N/A

Possible Solutions:

PROW/ADA:

Not Found, R304.2.3, R305,
R304.5.4, R304.5.3
