# Access Compliance Report

## Public Rights-of-Way

### (Curb Ramps)

| Intersection ID: 13408 | Main Street: COMMONWEALTH_AV | Cross Street: THE_PLAZA | Location: S |

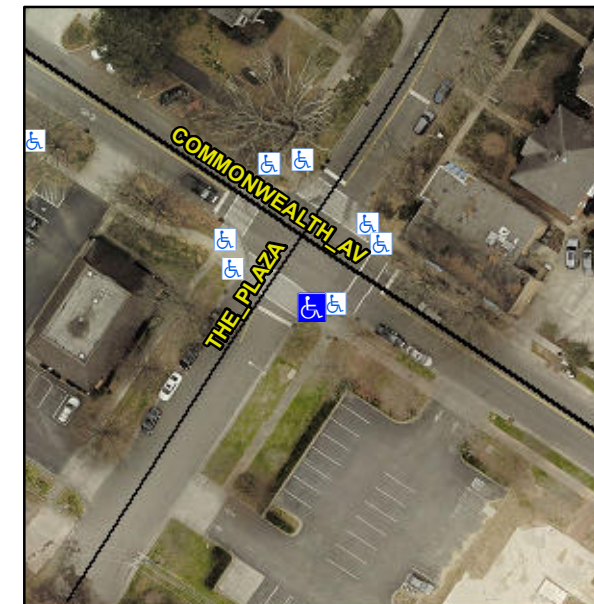
| Severity Score: 10 | | | |

**CURB GAP 1.0**

**Not Found, R304.2.2-Perp, R304.3.2-  
Para, R304.5.3, R305.1.4, R305.2,  
R302.7.2**

| Compliance | Description | Data | Compliance | Description | Data |
|---|---|---|---|---|---|
| Yes | Ramp Width (in) | 58.0 | No | Grade Break Slope (%) | 7.6 |
| No | Landing Slope (%) | 3.1 | Yes | DWS Length (in) | 24.0 |
| No | Landing X Slope (%) | 4.7 | No | DWS Full Width? | No |
| No | Gutter Lip Ht (in) | 0.5 | No | Gutter X Slope (%) | 2.3 |

Possible Solutions:

**Remove & Replace Entire Ramp.  
Remove & Replace Gutter.**

Total Cost: \$ 2350.00
