Intersection ID: N/A	Main Street: TRYON_ST	Cross Street: OAK_HILL_VILLAGE_LN	Location:	NW
ADA ID: D63C1B9275F2	Ramp Type: PerpDiag	Initial Pass/Fail: Fail	Overall Compliance: No	Severity Score: 13.75

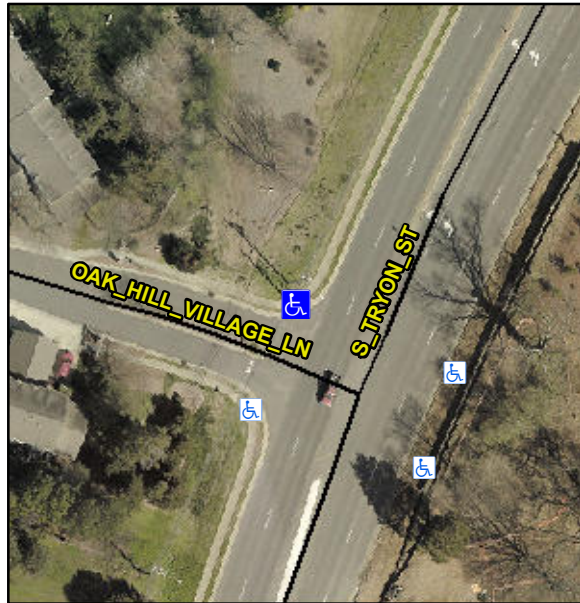
R304.2.2, R304.5.3

Compliance	Description	Data	Compliance	Description	Data
N/A	Ramp Length (in)	88.0	No	Ramp Slope (%)	8.5
Yes	Ramp Width (in)	48.0	No	Ramp XSlope (%)	3.1
N/A	Flare Type LT	N/A	N/A	Flare Type RT	N/A
N/A	Flare Slope LT (%)	N/A	N/A	Flare Slope RT (%)	N/A
N/A	Flare Traversable LT?	N/A	N/A	Flare Traversable RT?	N/A
N/A	Landing Length (in)	N/A	N/A	DWS Provided?	N/A
N/A	Landing Width (in)	N/A	N/A	DWS Contrast?	N/A
N/A	Landing Slope (%)	N/A	N/A	DWS Length (in)	N/A
N/A	Landing X Slope (%)	N/A	N/A	DWS Full Width?	N/A
N/A	Landing Curb? (Y/N)	N/A	N/A	DWS Offset (in)	N/A
N/A	Shared Landing?	N/A			
N/A	Gutter Ponding?	N/A	N/A	Gutter Slope (%)	N/A
N/A	Gutter Lip Ht (in)	N/A	N/A	Gutter X Slope (%)	N/A
N/A	Painted X Walk1?	No	N/A	Painted X Walk2?	No
	X Walk 1 Direction	To SW		X Walk 2 Direction	To SE
N/A	X Walk 1 Width (in)	N/A	N/A	X Walk 2 Width (in)	N/A
	X Walk 1 Slope (%)	6.6		X Walk 2 Slope (%)	0.9
	X Walk 1 X Slope (%)	2.3		X Walk 2 X Slope (%)	2.6

N/A	Ramp inside XWalk1?	N/A	N/A	Ramp inside XWalk2?	N/A
	Road Slope (%)	2.1	N/A	Clear Space?	N/A
	Road X Slope (%)	2.4	N/A	Clear Space to XWalk (in)	N/A
N/A	Any Obstructions?	N/A	N/A	Storm Grate/Utility Hazard?	N/A
	Obstruction Type			Storm Grate/Utility Type	
		N/A			N/A
			Yes	Surface Condition? (G/P)	Good

Remove & Replace Curb Ramp With Two New Directional Ramps or Equivalent.
