Access Compliance Report Public Rights-of-Way (Curb Ramps)

Intersection ID: 47164 Main Street: SOUTH PARK DR **Cross Street: FAIRVIEW RD** Location: NW ADA ID: D63C99F06A80 Ramp Type: Perp Initial Pass/Fail: Fail **Overall Compliance: No** 12.5 **Severity Score:**

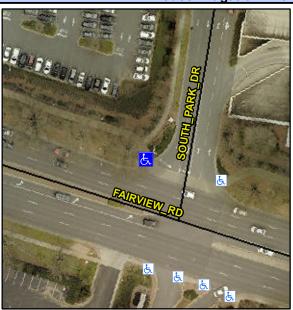
6.7

5.6

Ramp Slope (%)

Ramp XSlope (%)

| Possible Solutions: | | | | | |
|---|--|--|--|--|--|
| Remove & Replace Entire Ramp. | | | | | |
| R304.5.3 | | | | | |

| 7 | | | IN/A |
|---|---|---|---|
| | Total Cost: | \$ 1850.00 | N/A |
