# Access Compliance Report

## Public Rights-of-Way

### (Curb Ramps)

| Intersection ID: N/A | Main Street: SUMMERFIELD RIDGE LN | Cross Street: LITTLE STREAM DR | Location: NW |

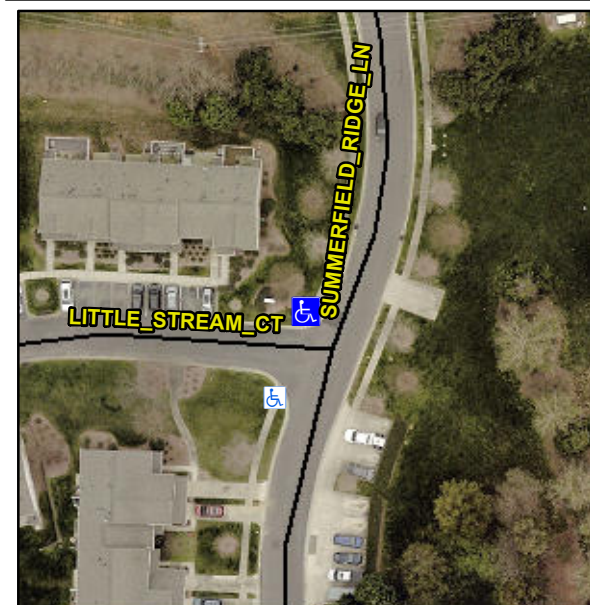
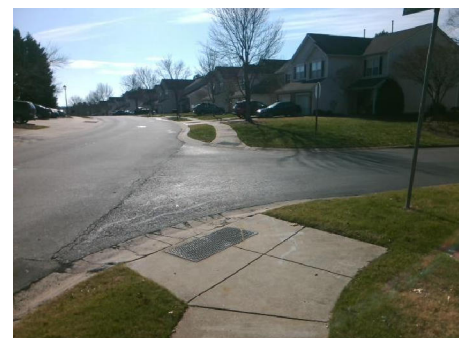
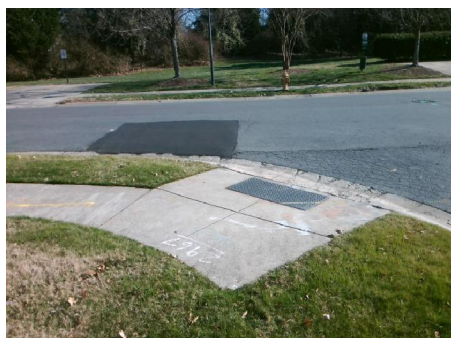
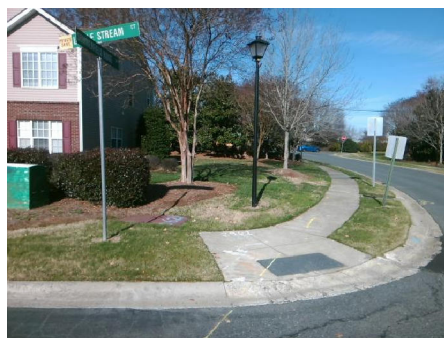
**DAMAGED GTR**

**R304.2.1, R304.2.2-Perp, R304.3.2-Para, R305.1.4, R305.2, R304.5.4, R304.5.3**

| Compliance | Description | Data | Compliance | Description | Data |
|---|---|---|---|---|---|
| No | Landing Length (in) | 47.0 | Yes | DWS Provided? | Yes |
| No | Landing Slope (%) | 2.7 | Yes | DWS Length (in) | 24.0 |
| Yes | Landing X Slope (%) | 0.6 | No | DWS Full Width? | No |
| Yes | Gutter Ponding? | No | No | Gutter Slope (%) | 9.9 |
| Yes | Gutter Lip Ht (in) | 0.0 | No | Gutter X Slope (%) | 2.1 |

**Remove & Replace Curb Ramp With Two New Directional Ramps or Equivalent. Remove & Replace Gutter.**
