Access Compliance Report

Public Rights-of-Way

(Curb Ramps)

Intersection ID: 42785	Main Street: CALDWELL_RD	Cross Street: OLD_STONE_CROSSING_DR	Location: S
ADA ID: D6513C03C207	Ramp Type: Combination1	Initial Pass/Fail: Fail	Overall Compliance: No
			Severity Score: 58.75

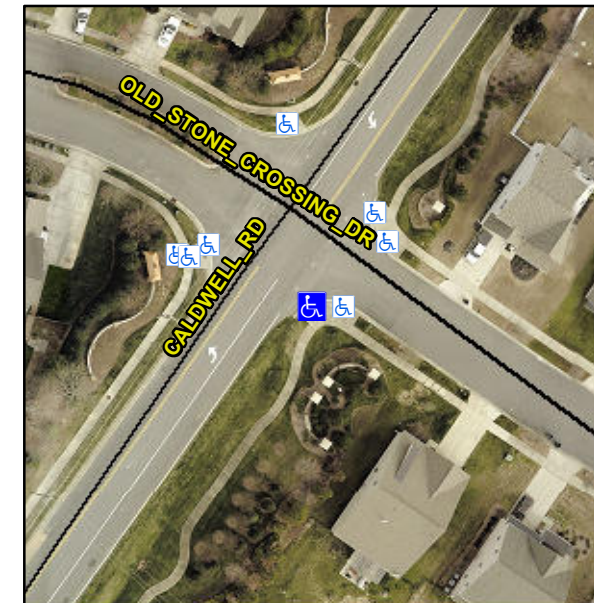
Not Found, R304.5.1, R304.5.3, R304.3.2

Compliance	Description	Data	Compliance	Description	Data
N/A	Ramp Length LT (in)	9.0	N/A	Ramp Length RT (in)	29.0
Yes	Ramp Width LT (in)	60.0	Yes	Ramp Width RT (in)	59.5
Yes	Ramp Slope LT (%)	6.8	No	Ramp Slope RT (%)	12.6
Yes	Ramp XSlope LT (%)	0.9	Yes	Ramp XSlope RT (%)	1.3
N/A	Ramp Length (in)	71.5	Yes	Ramp Slope (%)	0.2
No	Ramp Width (in)	47.0	No	Ramp XSlope (%)	9.0
N/A	Flare Type LT	N/A	N/A	Flare Type RT	N/A
N/A	Flare Slope LT (%)	N/A	N/A	Flare Slope RT (%)	N/A
N/A	Flare Traversable LT?	N/A	N/A	Flare Traversable RT?	N/A
N/A	Landing Length (in)	N/A	N/A	DWS Provided?	N/A
N/A	Landing Width (in)	N/A	N/A	DWS Contrast?	N/A
N/A	Landing Slope (%)	N/A	N/A	DWS Length (in)	N/A
N/A	Landing X Slope (%)	N/A	N/A	DWS Full Width?	N/A
N/A	Landing Curb? (Y/N)	N/A	N/A	DWS Offset (in)	N/A
N/A	Shared Landing?	N/A			
N/A	Gutter Ponding?	N/A	N/A	Gutter Slope (%)	N/A
N/A	Gutter Lip Ht (in)	N/A	N/A	Gutter X Slope (%)	N/A
N/A	Painted X Walk1?	No	N/A	Painted X Walk2?	N/A

X Walk 1 Direction	To NW		X Walk 2 Direction	N/A
	X Walk 1 Width (in)	N/A		X Walk 2 Width (in)	N/A
	X Walk 1 Slope (%)	3.0		X Walk 2 Slope (%)	N/A
	X Walk 1 X Slope (%)	0.7		X Walk 2 X Slope (%)	N/A
N/A	Ramp inside XWalk1?	N/A	N/A	Ramp inside XWalk2?	N/A
	Road Slope (%)	N/A		Clear Space?	N/A
	Road X Slope (%)	N/A	N/A	Clear Space to XWalk (in)	N/A
			N/A	Any Obstruction?	N/A
				Obstruction Type	N/A
			N/A	Storm Grate/Utility Hazard?	N/A
				Storm Grate/Utility Type	N/A
			Yes	Surface Condition? (G/P)	Good
				Curb Slope (%)	18.9

Remove & Replace Entire Ramp.

Total Cost: \$ 1800.00
