# Access Compliance Report

## Public Rights-of-Way

### (Curb Ramps)

Intersection ID: 15988	Main Street: SOUTH_BV	Cross Street: HOLLIS_RD	Location: NE
ADA ID: D656B168C3B0	Ramp Type: PerpDiag	Initial Pass/Fail: Fail	Overall Compliance: No
Severity Score: 21.25			
Codes/Mitigation Info/Possible Solution		Field Measurements/Component Compliance

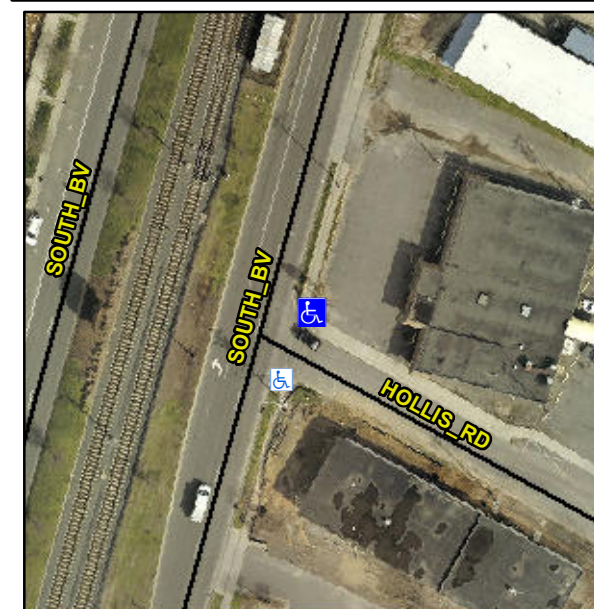
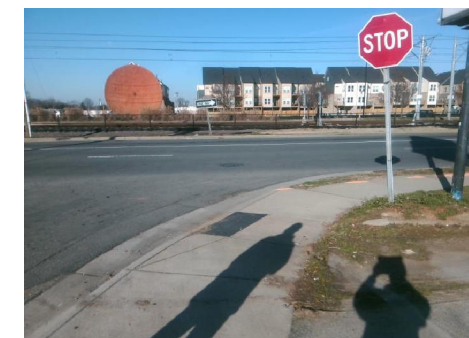
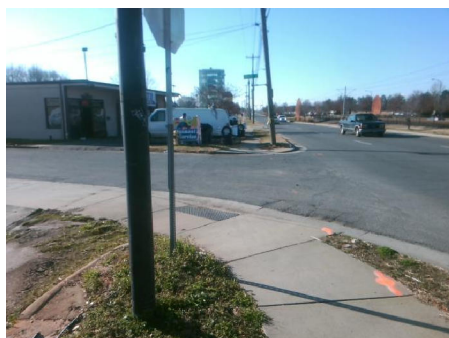
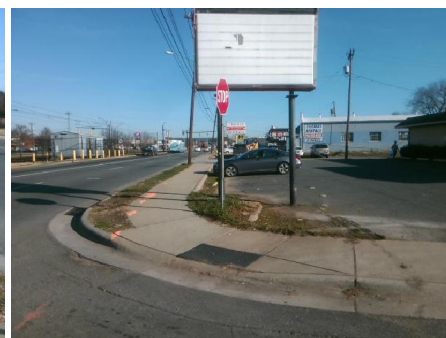
**Not Found, R304.5.1, R304.2.2**

Compliance	Description	Data	Compliance	Description	Data
N/A	Ramp Length (in)	72.0	No	Ramp Slope (%)	8.5
No	Ramp Width (in)	47.0	Yes	Ramp XSlope (%)	0.7
N/A	Flare Type LT	N/A	N/A	Flare Type RT	N/A
N/A	Flare Slope LT (%)	N/A	N/A	Flare Slope RT (%)	N/A
N/A	Flare Traversable LT?	N/A	N/A	Flare Traversable RT?	N/A
N/A	Landing Length (in)	N/A	N/A	DWS Provided?	N/A
N/A	Landing Width (in)	N/A	N/A	DWS Contrast?	N/A
N/A	Landing Slope (%)	N/A	N/A	DWS Length (in)	N/A
N/A	Landing X Slope (%)	N/A	N/A	DWS Full Width?	N/A
N/A	Landing Curb? (Y/N)	N/A	N/A	DWS Offset (in)	N/A
N/A	Shared Landing?	N/A			
N/A	Gutter Ponding?	N/A	N/A	Gutter Slope (%)	N/A
N/A	Gutter Lip Ht (in)	N/A	N/A	Gutter X Slope (%)	N/A
N/A	Painted X Walk1?	No	N/A	Painted X Walk2?	No
	X Walk 1 Direction	To NW		X Walk 2 Direction	To SW
N/A	X Walk 1 Width (in)	N/A	N/A	X Walk 2 Width (in)	N/A
	X Walk 1 Slope (%)	3.9		X Walk 2 Slope (%)	0.3
	X Walk 1 X Slope (%)	6.2		X Walk 2 X Slope (%)	0.8

N/A	Ramp inside XWalk1?	N/A	N/A	Ramp inside XWalk2?	N/A
	Road Slope (%)	0.5	N/A	Clear Space?	N/A
	Road X Slope (%)	0.3	N/A	Clear Space to XWalk (in)	N/A
N/A	Any Obstructions?	N/A	N/A	Storm Grate/Utility Hazard?	N/A
	Obstruction Type			Storm Grate/Utility Type	
		N/A			N/A
			Yes	Surface Condition? (G/P)	Good

**Remove & Replace Curb Ramp With Two New Directional Ramps or Equivalent.**
