# Access Compliance Report

## Public Rights-of-Way

### (Curb Ramps)

Intersection ID: 10014519	Main Street: UNIVERSITY_POINTE_BV	Cross Street: N/A	Location: NE
ADA ID: D668D61FEE43	Ramp Type: Perp	Initial Pass/Fail: Fail	Overall Compliance: No
			Severity Score: 21.25

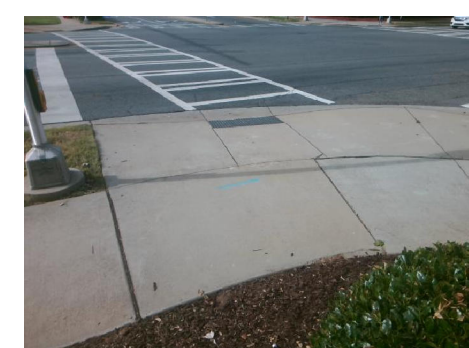
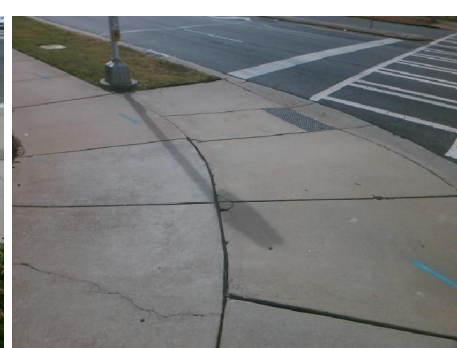
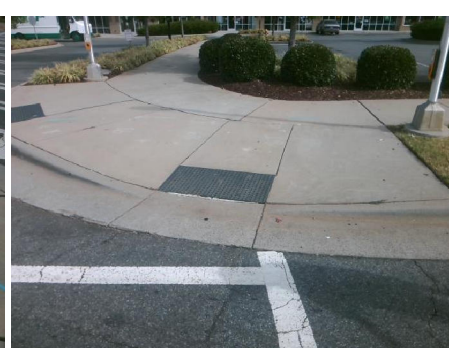
Possible Solutions:		<b>Compliance</b>	<b>Description</b>	<b>Data</b>
	<b>Remove &amp; Replace Entire Ramp.</b>		<b>No</b>	Ramp Length (in)	<b>96.0</b>
			<b>No</b>	Ramp Width (in)	<b>43.0</b>
			<b>N/A</b>	Flare Type LT	<b>N/A</b>
			<b>N/A</b>	Flare Slope LT (%)	<b>N/A</b>
			<b>N/A</b>	Flare Traversable LT?	<b>N/A</b>
			<b>N/A</b>	Landing Length (in)	<b>N/A</b>
			<b>N/A</b>	Landing Width (in)	<b>N/A</b>
			<b>N/A</b>	Landing Slope (%)	<b>N/A</b>
			<b>N/A</b>	Landing X Slope (%)	<b>N/A</b>
<p>Surveyor Notes:</p> <p><b>N/A</b></p> <p>PROW/ADA:</p> <p><b>Not Found, R304.5.1, R304.2.2</b></p>			<b>N/A</b>	Flare Type RT	<b>N/A</b>
			<b>N/A</b>	Flare Slope RT (%)	<b>N/A</b>
			<b>N/A</b>	Flare Traversable RT?	<b>N/A</b>
			<b>N/A</b>	DWS Provided?	<b>N/A</b>
			<b>N/A</b>	DWS Contrast?	<b>N/A</b>
			<b>N/A</b>	DWS Length (in)	<b>N/A</b>

<b>N/A</b>	DWS Full Width?	<b>N/A</b>
			<b>N/A</b>	DWS Offset (in)	<b>N/A</b>
			<b>N/A</b>	Gutter Ponding?	<b>N/A</b>
			<b>N/A</b>	Gutter Lip Ht (in)	<b>N/A</b>
			<b>N/A</b>	Painted X Walk1?	<b>Yes</b>
				X Walk 1 Direction	<b>To S</b>
			<b>N/A</b>	X Walk 1 Width (in)	<b>99.0</b>
				X Walk 1 Slope (%)	<b>4.2</b>
				X Walk 1 X Slope (%)	<b>1.1</b>
			<b>N/A</b>	Ramp inside XWalk1?	<b>Yes</b>
				Road Slope (%)	<b>N/A</b>
				Road X Slope (%)	<b>N/A</b>
			<b>N/A</b>	Any Obstructions?	<b>N/A</b>
				Obstruction Type	
Total Cost:					
		<b>\$ 1850.00</b>			
			<b>N/A</b>		<b>N/A</b>
			<b>Yes</b>	Surface Condition? (G/P)	<b>Good</b>
