Access Compliance Report

Public Rights-of-Way

(Curb Ramps)

Intersection ID: 49184	Main Street: ST_GERMAINE_LN	Cross Street: ST_STEPHEN_LN	Location: NE
ADA ID: D6834F5EA36D	Ramp Type: PerpDiag	Initial Pass/Fail: Fail	Overall Compliance: No
Severity Score: 35			
Codes/Mitigation Info/Possible Solution		Field Measurements/Component Compliance

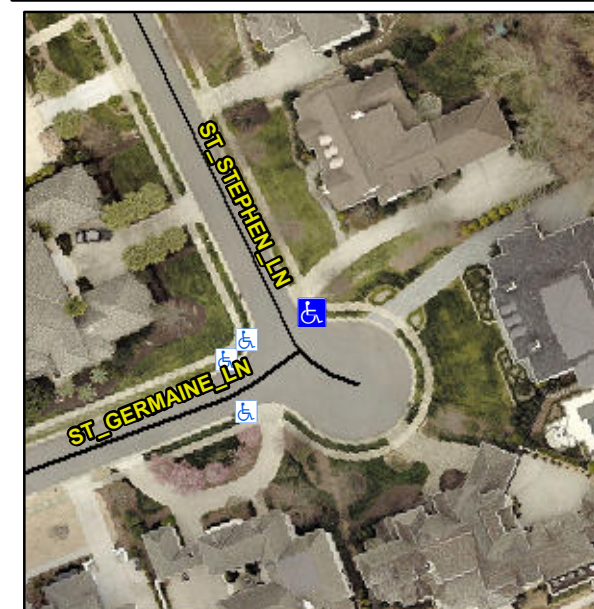
Compliance	Description	Data	Compliance	Description	Data
N/A	Ramp Length (in)	52.0	No	Ramp Slope (%)	13.5
No	Ramp Width (in)	47.5	No	Ramp XSlope (%)	3.3
N/A	Flare Type LT	N/A	N/A	Flare Type RT	N/A
N/A	Flare Slope LT (%)	N/A	N/A	Flare Slope RT (%)	N/A
N/A	Flare Traversable LT?	N/A	N/A	Flare Traversable RT?	N/A
N/A	Landing Length (in)	N/A	N/A	DWS Provided?	N/A
N/A	Landing Width (in)	N/A	N/A	DWS Contrast?	N/A
N/A	Landing Slope (%)	N/A	N/A	DWS Length (in)	N/A
N/A	Landing X Slope (%)	N/A	N/A	DWS Full Width?	N/A
N/A	Landing Curb? (Y/N)	N/A	N/A	DWS Offset (in)	N/A
N/A	Shared Landing?	N/A			
N/A	Gutter Ponding?	N/A	N/A	Gutter Slope (%)	N/A
N/A	Gutter Lip Ht (in)	N/A	N/A	Gutter X Slope (%)	N/A
N/A	Painted X Walk1?	No	N/A	Painted X Walk2?	No
	X Walk 1 Direction	To W		X Walk 2 Direction	To S
N/A	X Walk 1 Width (in)	N/A	N/A	X Walk 2 Width (in)	N/A
	X Walk 1 Slope (%)	3.0		X Walk 2 Slope (%)	1.3
	X Walk 1 X Slope (%)	1.2		X Walk 2 X Slope (%)	1.3

N/A	Ramp inside XWalk1?	N/A	N/A	Ramp inside XWalk2?	N/A
	Road Slope (%)	3.2	N/A	Clear Space?	N/A
	Road X Slope (%)	2.0	N/A	Clear Space to XWalk (in)	N/A
N/A	Any Obstructions?	N/A	N/A	Storm Grate/Utility Hazard?	N/A
	Obstruction Type			Storm Grate/Utility Type	
		N/A			N/A
			Yes	Surface Condition? (G/P)	Good

Possible Solutions:

Remove & Replace Curb Ramp With Two New Directional Ramps or Equivalent.

R304.5.1, R304.2.2, R304.5.3
