Access Compliance Report

Public Rights-of-Way

(Curb Ramps)

Intersection ID: 52783	Main Street: TAYLOR RIDGE LN	Cross Street: WITHER STEELE CT	Location: SE
ADA ID: D68F1E1CE48A	Ramp Type: Perp	Initial Pass/Fail: Fail	Overall Compliance: No
Severity Score: 8.75			
Codes/Mitigation Info/Possible Solution		Field Measurements/Component Compliance

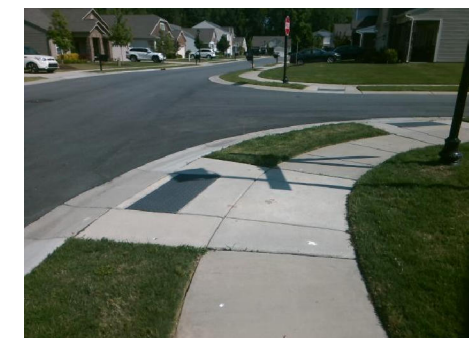
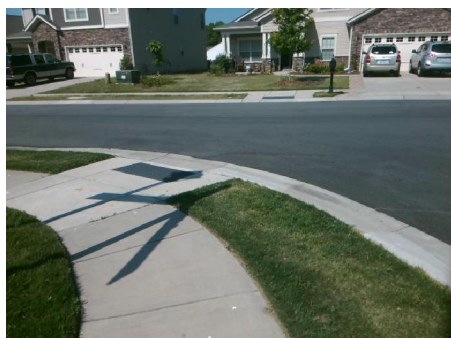
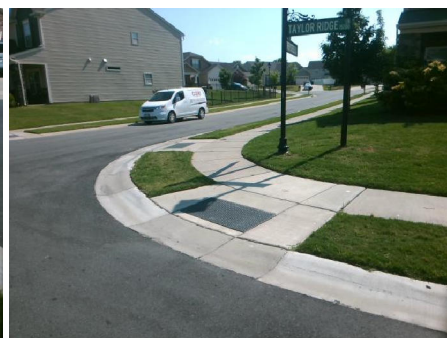
Not Found, R304.5.1

Compliance	Description	Data	Compliance	Description	Data
N/A	Ramp Length (in)	50.0	Yes	Ramp Slope (%)	7.8
No	Ramp Width (in)	46.0	Yes	Ramp XSlope (%)	0.6
N/A	Flare Type LT	N/A	N/A	Flare Type RT	N/A
N/A	Flare Slope LT (%)	N/A	N/A	Flare Slope RT (%)	N/A
N/A	Flare Traversable LT?	N/A	N/A	Flare Traversable RT?	N/A
N/A	Landing Length (in)	N/A	N/A	DWS Provided?	N/A
N/A	Landing Width (in)	N/A	N/A	DWS Contrast?	N/A
N/A	Landing Slope (%)	N/A	N/A	DWS Length (in)	N/A
N/A	Landing X Slope (%)	N/A	N/A	DWS Full Width?	N/A
N/A	Landing Curb? (Y/N)	N/A	N/A	DWS Offset (in)	N/A
N/A	Shared Landing?	N/A			
N/A	Gutter Ponding?	N/A	N/A	Gutter Slope (%)	N/A
N/A	Gutter Lip Ht (in)	N/A	N/A	Gutter X Slope (%)	N/A
N/A	Painted X Walk1?	No	N/A	Painted X Walk2?	N/A
	X Walk 1 Direction	To W		X Walk 2 Direction	N/A
N/A	X Walk 1 Width (in)	N/A	N/A	X Walk 2 Width (in)	N/A
	X Walk 1 Slope (%)	3.4		X Walk 2 Slope (%)	N/A
	X Walk 1 X Slope (%)	1.7		X Walk 2 X Slope (%)	N/A

N/A	Ramp inside XWalk1?	N/A	N/A	Ramp inside XWalk2?	N/A
	Road Slope (%)	N/A	N/A	Clear Space?	N/A
	Road X Slope (%)	N/A	N/A	Clear Space to XWalk (in)	N/A
N/A	Any Obstructions?	N/A	N/A	Storm Grate/Utility Hazard?	N/A
	Obstruction Type			Storm Grate/Utility Type	
		N/A			N/A
		Yes		Surface Condition? (G/P)	Good

Remove & Replace Entire Ramp.
