## **Access Compliance Report Public Rights-of-Way** (Curb Ramps)

Intersection ID: 12043 Main Street: CHESTNUT OAK LN Cross Street: TEANECK PL Location: SE Initial Pass/Fail: Fail **Overall Compliance: No Severity Score:** 12.5 ADA ID: D69CFCA82EF5 Ramp Type: PerpDiag

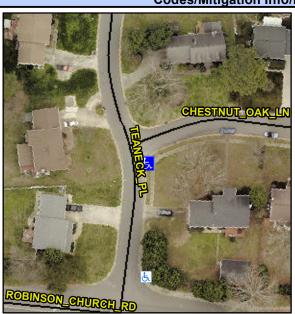
**CHESTNUT OAK LN** Street 1 Name Stop Condition-Street 2 StopSign **TEANECK PL** Street 2 Name Stop Condition-Street 1 None Possible Solutions: Remove & Replace Curb Ramp With Two New Directional Ramps or Equivalent. Surveyor Notes: N/A PROW/ADA: Not Found, R304.2.2
