# Access Compliance Report

## Public Rights-of-Way

### (Curb Ramps)

Intersection ID: 9396	Main Street: MORETZ_AV	Cross Street: N_GRAHAM_ST	Location: W
ADA ID: D6ACD9A8D705	Ramp Type: PerpDiag	Initial Pass/Fail: Fail	Overall Compliance: No
Codes/Mitigation Info/Possible Solution		Field Measurements/Component Compliance

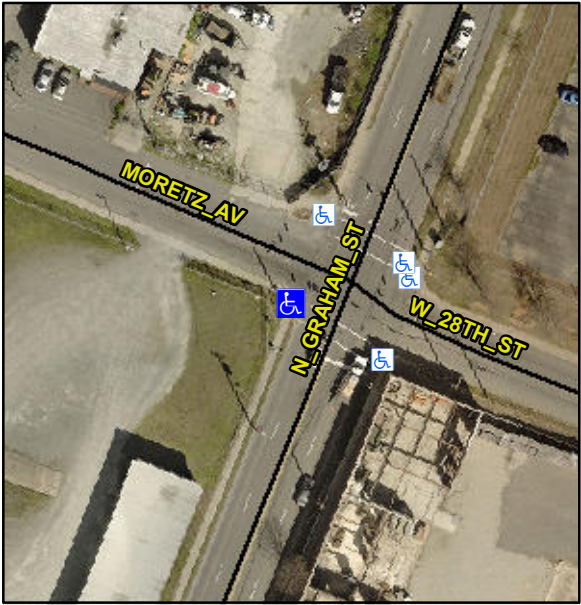
Possible Solutions:	Compliance	Description	Data	Compliance	Description	Data
	Remove & Replace Curb Ramp With Two New Directional Ramps or Equivalent.	N/A	Ramp Length (in)	34.0	No	Ramp Slope (%)	12.7
		No	Ramp Width (in)	36.0	Yes	Ramp XSlope (%)	1.3
		N/A	Flare Type LT	N/A	N/A	Flare Type RT	N/A
		N/A	Flare Slope LT (%)	N/A	N/A	Flare Slope RT (%)	N/A
		N/A	Flare Traversable LT?	N/A	N/A	Flare Traversable RT?	N/A
		N/A	Landing Length (in)	N/A	N/A	DWS Provided?	N/A
		N/A	Landing Width (in)	N/A	N/A	DWS Contrast?	N/A
		N/A	Landing Slope (%)	N/A	N/A	DWS Length (in)	N/A
		N/A	Landing X Slope (%)	N/A	N/A	DWS Full Width?	N/A
<p>Surveyor Notes:</p> <p>N/A</p> <p>PROW/ADA:</p> <p>Not Found, R304.5.1, R304.2.2</p>		N/A	Landing Curb? (Y/N)	N/A	N/A	DWS Offset (in)	N/A
		N/A	Shared Landing?	N/A			
		N/A	Gutter Ponding?	N/A	N/A	Gutter Slope (%)	N/A
		N/A	Gutter Lip Ht (in)	1.0	N/A	Gutter X Slope (%)	N/A
		N/A	Painted X Walk1?	Yes	N/A	Painted X Walk2?	No

X Walk 1 Direction	To SE		X Walk 2 Direction	To NE
		N/A	X Walk 1 Width (in)	101.0	N/A	X Walk 2 Width (in)	N/A
			X Walk 1 Slope (%)	0.5		X Walk 2 Slope (%)	0.4
			X Walk 1 X Slope (%)	1.2		X Walk 2 X Slope (%)	1.9
		N/A	Ramp inside XWalk1?	Yes	N/A	Ramp inside XWalk2?	N/A
<p>Total Cost:</p> <p>\$ 3200.00</p>			Road Slope (%)	3.3	N/A	Clear Space?	N/A
			Road X Slope (%)	0.7	N/A	Clear Space to XWalk (in)	N/A
		N/A	Any Obstructions?	N/A	N/A	Storm Grate/Utility Hazard?	N/A
			Obstruction Type			Storm Grate/Utility Type	
				N/A			N/A
					Yes	Surface Condition? (G/P)	Good
