# Access Compliance Report

## Public Rights-of-Way

### (Curb Ramps)

Intersection ID: 26432	Main Street: BEVINGTON_BROOK_LN	Cross Street: BEVINGTON_PL	Location: NW
ADA ID: D6B27AF647AB	Ramp Type: PerpDiag	Initial Pass/Fail: Fail	Overall Compliance: No
Severity Score: 46.25			
Codes/Mitigation Info/Possible Solution		Field Measurements/Component Compliance

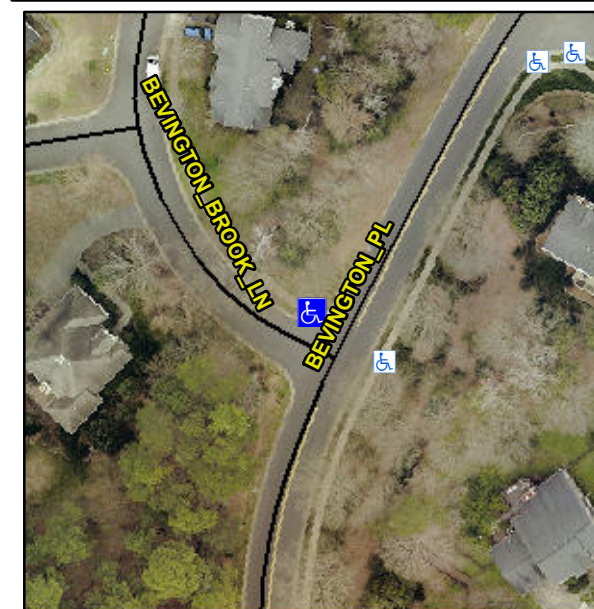
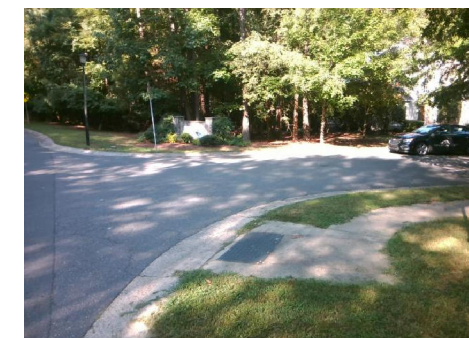
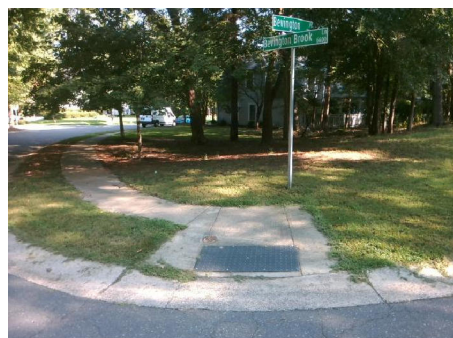
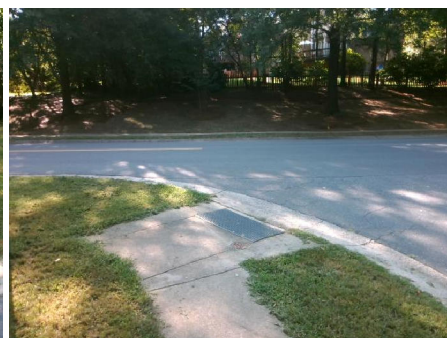
Compliance	Description	Data	Compliance	Description	Data
N/A	Ramp Length (in)	89.0	No	Ramp Slope (%)	11.6
No	Ramp Width (in)	43.0	No	Ramp XSlope (%)	7.2
N/A	Flare Type LT	N/A	N/A	Flare Type RT	N/A
N/A	Flare Slope LT (%)	N/A	N/A	Flare Slope RT (%)	N/A
N/A	Flare Traversable LT?	N/A	N/A	Flare Traversable RT?	N/A
N/A	Landing Length (in)	N/A	N/A	DWS Provided?	N/A
N/A	Landing Width (in)	N/A	N/A	DWS Contrast?	N/A
N/A	Landing Slope (%)	N/A	N/A	DWS Length (in)	N/A
N/A	Landing X Slope (%)	N/A	N/A	DWS Full Width?	N/A
N/A	Landing Curb? (Y/N)	N/A	N/A	DWS Offset (in)	N/A
N/A	Shared Landing?	N/A			
N/A	Gutter Ponding?	N/A	N/A	Gutter Slope (%)	N/A
N/A	Gutter Lip Ht (in)	N/A	N/A	Gutter X Slope (%)	N/A
N/A	Painted X Walk1?	No	N/A	Painted X Walk2?	No
	X Walk 1 Direction	To SW		X Walk 2 Direction	To SE
N/A	X Walk 1 Width (in)	N/A	N/A	X Walk 2 Width (in)	N/A
	X Walk 1 Slope (%)	1.4		X Walk 2 Slope (%)	4.4
	X Walk 1 X Slope (%)	7.4		X Walk 2 X Slope (%)	1.3

N/A	Ramp inside XWalk1?	N/A	N/A	Ramp inside XWalk2?	N/A
	Road Slope (%)	7.5	N/A	Clear Space?	N/A
	Road X Slope (%)	4.8	N/A	Clear Space to XWalk (in)	N/A
N/A	Any Obstructions?	N/A	N/A	Storm Grate/Utility Hazard?	N/A
	Obstruction Type			Storm Grate/Utility Type	
		N/A			N/A
			Yes	Surface Condition? (G/P)	Good

**Remove & Replace Curb Ramp With Two New Directional Ramps or Equivalent.**

**R304.5.1, R304.2.2, R304.5.3**
