Access Compliance Report

Public Rights-of-Way

(Curb Ramps)

Intersection ID: 43513	Main Street: BLACKBERRY RIDGE LN	Cross Street: MULBERRY POND DR	Location: SW
ADA ID: D6B825D8D638	Ramp Type: PerpDiag	Initial Pass/Fail: Fail	Overall Compliance: No
Severity Score: 10			
Codes/Mitigation Info/Possible Solution		Field Measurements/Component Compliance

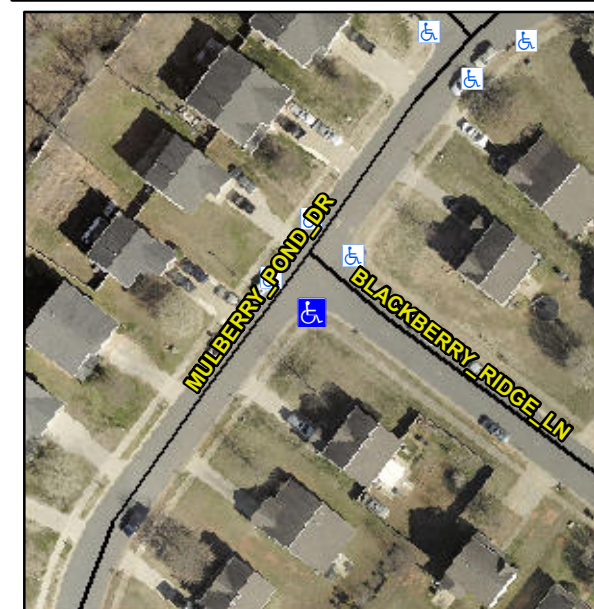
Not Found, R304.5.1, R304.5.3

Compliance	Description	Data	Compliance	Description	Data
N/A	Ramp Length (in)	46.0	Yes	Ramp Slope (%)	6.0
No	Ramp Width (in)	40.5	No	Ramp XSlope (%)	3.0
N/A	Flare Type LT	N/A	N/A	Flare Type RT	N/A
N/A	Flare Slope LT (%)	N/A	N/A	Flare Slope RT (%)	N/A
N/A	Flare Traversable LT?	N/A	N/A	Flare Traversable RT?	N/A
N/A	Landing Length (in)	N/A	N/A	DWS Provided?	N/A
N/A	Landing Width (in)	N/A	N/A	DWS Contrast?	N/A
N/A	Landing Slope (%)	N/A	N/A	DWS Length (in)	N/A
N/A	Landing X Slope (%)	N/A	N/A	DWS Full Width?	N/A
N/A	Landing Curb? (Y/N)	N/A	N/A	DWS Offset (in)	N/A
N/A	Shared Landing?	N/A			
N/A	Gutter Ponding?	N/A	N/A	Gutter Slope (%)	N/A
N/A	Gutter Lip Ht (in)	N/A	N/A	Gutter X Slope (%)	N/A
N/A	Painted X Walk1?	No	N/A	Painted X Walk2?	No
	X Walk 1 Direction	To NE		X Walk 2 Direction	To NW
N/A	X Walk 1 Width (in)	N/A	N/A	X Walk 2 Width (in)	N/A
	X Walk 1 Slope (%)	0.4		X Walk 2 Slope (%)	1.7
	X Walk 1 X Slope (%)	0.7		X Walk 2 X Slope (%)	1.3

N/A	Ramp inside XWalk1?	N/A	N/A	Ramp inside XWalk2?	N/A
	Road Slope (%)	1.3	N/A	Clear Space?	N/A
	Road X Slope (%)	1.6	N/A	Clear Space to XWalk (in)	N/A
N/A	Any Obstructions?	N/A	N/A	Storm Grate/Utility Hazard?	N/A
	Obstruction Type			Storm Grate/Utility Type	
		N/A			N/A
			Yes	Surface Condition? (G/P)	Good

Possible Solutions:

Remove & Replace Curb Ramp With Two New Directional Ramps or Equivalent.
