Access Compliance Report

Public Rights-of-Way

(Curb Ramps)

Intersection ID: 15316	Main Street: CARLING_AV	Cross Street: CHARLOTTE_DR	Location: W
ADA ID: D6C13DEFD228	Ramp Type: Perp	Initial Pass/Fail: Fail	Overall Compliance: No
		Severity Score: 25

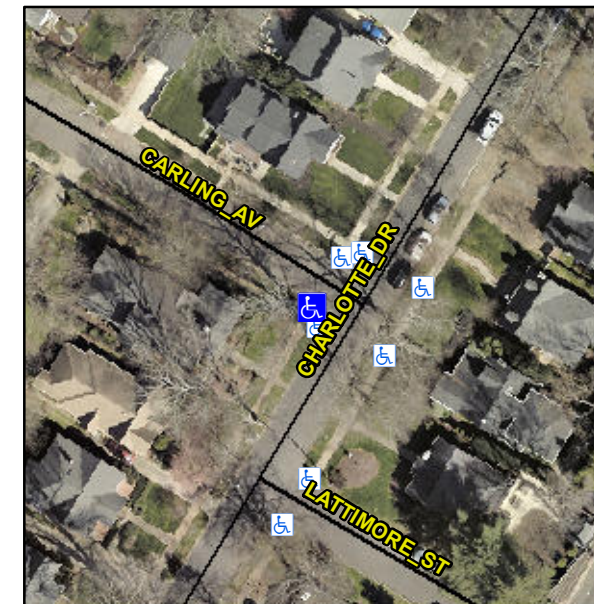
Not Found, R304.5.3

Compliance	Description	Data	Compliance	Description	Data
N/A	Ramp Length (in)	68.0	Yes	Ramp Slope (%)	7.4
Yes	Ramp Width (in)	48.0	No	Ramp XSlope (%)	8.6
N/A	Flare Type LT	N/A	N/A	Flare Type RT	N/A
N/A	Flare Slope LT (%)	N/A	N/A	Flare Slope RT (%)	N/A
N/A	Flare Traversable LT?	N/A	N/A	Flare Traversable RT?	N/A
N/A	Landing Length (in)	N/A	N/A	DWS Provided?	N/A
N/A	Landing Width (in)	N/A	N/A	DWS Contrast?	N/A
N/A	Landing Slope (%)	N/A	N/A	DWS Length (in)	N/A
N/A	Landing X Slope (%)	N/A	N/A	DWS Full Width?	N/A
N/A	Landing Curb? (Y/N)	N/A	N/A	DWS Offset (in)	N/A
N/A	Shared Landing?	N/A			
N/A	Gutter Ponding?	N/A	N/A	Gutter Slope (%)	N/A
N/A	Gutter Lip Ht (in)	1.0	N/A	Gutter X Slope (%)	N/A
N/A	Painted X Walk1?	No	N/A	Painted X Walk2?	N/A
	X Walk 1 Direction	To NE		X Walk 2 Direction	N/A
N/A	X Walk 1 Width (in)	N/A	N/A	X Walk 2 Width (in)	N/A
	X Walk 1 Slope (%)	2.7		X Walk 2 Slope (%)	N/A
	X Walk 1 X Slope (%)	2.6		X Walk 2 X Slope (%)	N/A

Possible Solutions:

Remove & Replace Entire Ramp.
