Intersection ID: 15292	Main Street: EAST_BV	Cross Street: FOUNTAIN_VIEW	Location:	N
ADA ID: D6CD3D87A45F	Ramp Type: PerpDiag	Initial Pass/Fail: Fail	Overall Compliance: No	Severity Score: 8.75

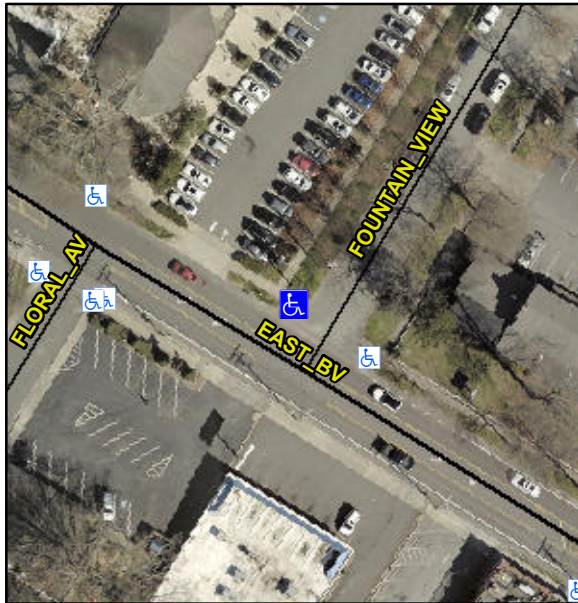
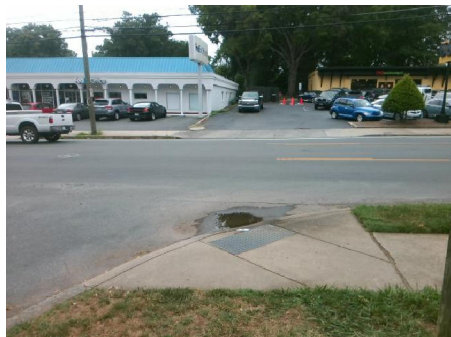
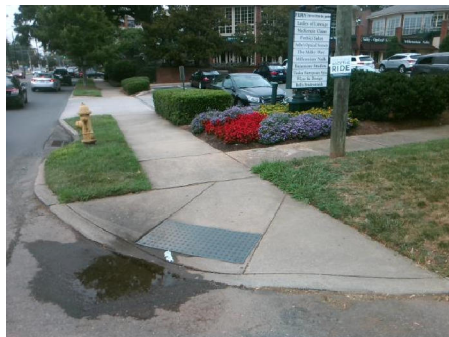
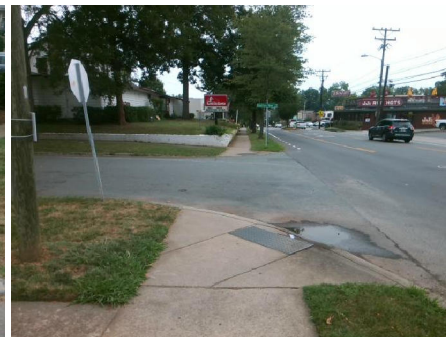
R304.5.1

Compliance	Description	Data	Compliance	Description	Data
N/A	Ramp Length (in)	85.0	Yes	Ramp Slope (%)	5.4
No	Ramp Width (in)	46.0	Yes	Ramp XSlope (%)	1.6
N/A	Flare Type LT	N/A	N/A	Flare Type RT	N/A
N/A	Flare Slope LT (%)	N/A	N/A	Flare Slope RT (%)	N/A
N/A	Flare Traversable LT?	N/A	N/A	Flare Traversable RT?	N/A
N/A	Landing Length (in)	N/A	N/A	DWS Provided?	N/A
N/A	Landing Width (in)	N/A	N/A	DWS Contrast?	N/A
N/A	Landing Slope (%)	N/A	N/A	DWS Length (in)	N/A
N/A	Landing X Slope (%)	N/A	N/A	DWS Full Width?	N/A
N/A	Landing Curb? (Y/N)	N/A	N/A	DWS Offset (in)	N/A
N/A	Shared Landing?	N/A			
N/A	Gutter Ponding?	N/A	N/A	Gutter Slope (%)	N/A
N/A	Gutter Lip Ht (in)	N/A	N/A	Gutter X Slope (%)	N/A
N/A	Painted X Walk1?	No	N/A	Painted X Walk2?	No
	X Walk 1 Direction	To SW		X Walk 2 Direction	To SE
N/A	X Walk 1 Width (in)	N/A	N/A	X Walk 2 Width (in)	N/A
	X Walk 1 Slope (%)	1.5		X Walk 2 Slope (%)	4.1
	X Walk 1 X Slope (%)	1.2		X Walk 2 X Slope (%)	1.9

N/A	Ramp inside XWalk1?	N/A	N/A	Ramp inside XWalk2?	N/A
	Road Slope (%)	0.1	N/A	Clear Space?	N/A
	Road X Slope (%)	1.2	N/A	Clear Space to XWalk (in)	N/A
N/A	Any Obstructions?	N/A	N/A	Storm Grate/Utility Hazard?	N/A
	Obstruction Type			Storm Grate/Utility Type	
		N/A			N/A
			Yes	Surface Condition? (G/P)	Good

Remove & Replace Curb Ramp With Two New Directional Ramps or Equivalent.

Total Cost: \$ 3200.00
