Access Compliance Report Public Rights-of-Way (Curb Ramps)

Intersection ID: 10033789 Main Street: PACIFIC ECHO DR Cross Street: N/A Location: NW ADA ID: D6D46758C8A7 Ramp Type: Perp Initial Pass/Fail: Fail **Overall Compliance: No Severity Score:** 22.5

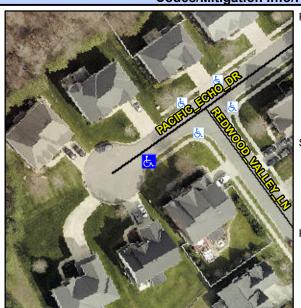
Field Measurements/Component Compliance								
Compl	iance Description	Data	Compl	iance	Description	Data		
N/A	Ramp Length (in)	49.0	No	Ramp	Slope (%)	9.5		
No	Ramp Width (in)	47.0	No	Ramp	XSlope (%)	2.9		
N/A	Flare Type LT	N/A	N/A	Flare Type RT		N/A		
N/A	Flare Slope LT (%)	N/A	N/A	Flare Slope RT (%)		N/A		
N/A	Flare Traversable LT?	N/A	N/A	Flare Traversable RT?		N/A		
N/A	Landing Length (in)	N/A	N/A	DWS	Provided?	N/A		
N/A	Landing Width (in)	N/A	N/A	DWS	Contrast?	N/A		
N/A	Landing Slope (%)	N/A	N/A	DWS	Length (in)	N/A		
N/A	Landing X Slope (%)	N/A	N/A	DWS	Full Width?	N/A		
N/A	Landing Curb? (Y/N)	N/A	N/A	DWS	Offset (in)	N/A		
N/A	Shared Landing?	N/A						
N/A	Gutter Ponding?	N/A	N/A	Gutte	er Slope (%)	N/A		
N/A	Gutter Lip Ht (in)	N/A	N/A	Gutte	r X Slope (%)	N/A		
N/A	Painted X Walk1?	No	N/A	Paint	ed X Walk2?	N/A		
	X Walk 1 Direction	To NW		X Wa	lk 2 Direction	N/A		
N/A	X Walk 1 Width (in)	N/A	N/A	X Wa	lk 2 Width (in)	N/A

X Walk 1 Slope (%)	1.0		X Wa	lk 2 Slope (%)	N/A		
	X Walk 1 X Slope (%)	2.6		X Wa	lk 2 X Slope (%)	N/A		
N/A	Ramp inside XWalk1?	N/A	N/A	Ram	inside XWalk2?	N/A		
	Road Slope (%)	N/A	N/A	Clear	Space?	N/A		
	Road X Slope (%)	N/A	N/A	Clear	Space to XWalk (in)	N/A		
N/A	Any Obstructions?	N/A	N/A	Storn	n Grate/Utility Hazard?	N/A		
	Obstruction Type			Storn	n Grate/Utility Type			
		N/A				N/A		
			Yes	Surfa	ce Condition? (G/P)	Good		
. 44.30	. O D 1

Possible Solutions: Remove & Replace Entire Ramp. Surveyor Notes: N/A PROW/ADA: Not Found, R304.5.1, R304.2.2, R304.5.3
