Access Compliance Report

Public Rights-of-Way

(Curb Ramps)

Intersection ID: 46223	Main Street: COBLE_AV	Cross Street: PARKERS_CROSSING_DR	Location: SE
ADA ID: D6EE98BADDFD	Ramp Type: PerpDiag	Initial Pass/Fail: Fail	Overall Compliance: No
Severity Score: 8.75			
Codes/Mitigation Info/Possible Solution		Field Measurements/Component Compliance

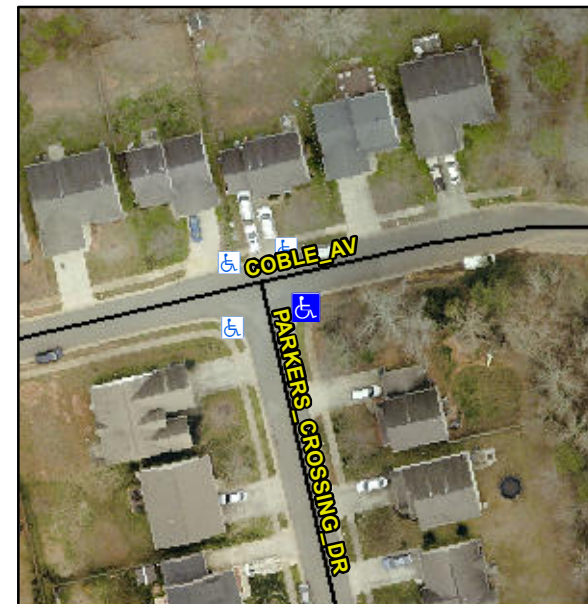
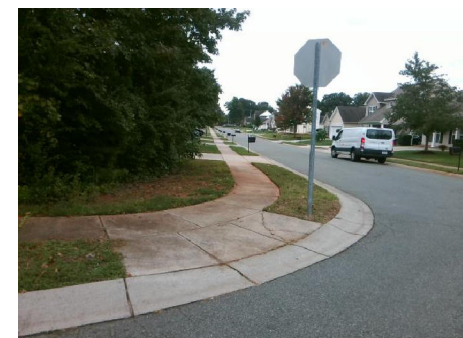
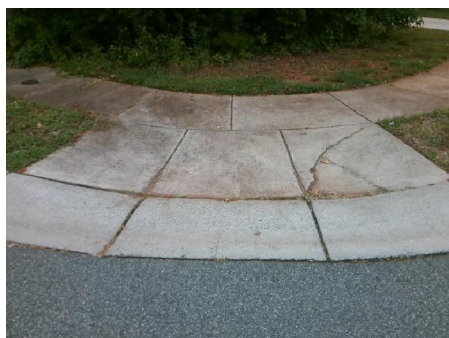
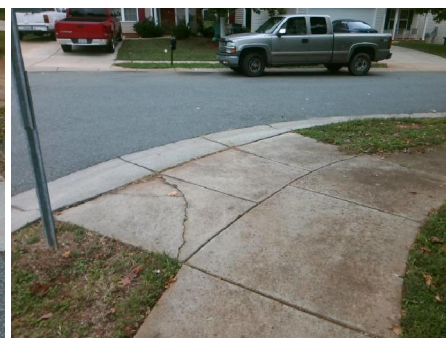
Not Found, R304.5.1

Compliance	Description	Data	Compliance	Description	Data
N/A	Ramp Length (in)	49.0	Yes	Ramp Slope (%)	5.0
No	Ramp Width (in)	36.5	Yes	Ramp XSlope (%)	0.4
N/A	Flare Type LT	N/A	N/A	Flare Type RT	N/A
N/A	Flare Slope LT (%)	N/A	N/A	Flare Slope RT (%)	N/A
N/A	Flare Traversable LT?	N/A	N/A	Flare Traversable RT?	N/A
N/A	Landing Length (in)	N/A	N/A	DWS Provided?	N/A
N/A	Landing Width (in)	N/A	N/A	DWS Contrast?	N/A
N/A	Landing Slope (%)	N/A	N/A	DWS Length (in)	N/A
N/A	Landing X Slope (%)	N/A	N/A	DWS Full Width?	N/A
N/A	Landing Curb? (Y/N)	N/A	N/A	DWS Offset (in)	N/A
N/A	Shared Landing?	N/A			
N/A	Gutter Ponding?	N/A	N/A	Gutter Slope (%)	N/A
N/A	Gutter Lip Ht (in)	N/A	N/A	Gutter X Slope (%)	N/A
N/A	Painted X Walk1?	No	N/A	Painted X Walk2?	No
	X Walk 1 Direction	To N		X Walk 2 Direction	To W
N/A	X Walk 1 Width (in)	N/A	N/A	X Walk 2 Width (in)	N/A
	X Walk 1 Slope (%)	1.4		X Walk 2 Slope (%)	1.4
	X Walk 1 X Slope (%)	1.1		X Walk 2 X Slope (%)	2.0

N/A	Ramp inside XWalk1?	N/A	N/A	Ramp inside XWalk2?	N/A
	Road Slope (%)	0.2	N/A	Clear Space?	N/A
	Road X Slope (%)	1.2	N/A	Clear Space to XWalk (in)	N/A
N/A	Any Obstructions?	N/A	N/A	Storm Grate/Utility Hazard?	N/A
	Obstruction Type			Storm Grate/Utility Type	
		N/A			N/A
		Yes		Surface Condition? (G/P)	Good

Remove & Replace Curb Ramp With Two New Directional Ramps or Equivalent.
