Intersection ID: 15177	Main Street: CHARLOTTE_DR	Cross Street: E WORTHINGTON AV	Location:	W
ADA ID: D6FC5B3EE97D	Ramp Type: Perp	Initial Pass/Fail: Fail	Overall Compliance: No	Severity Score: 26.25

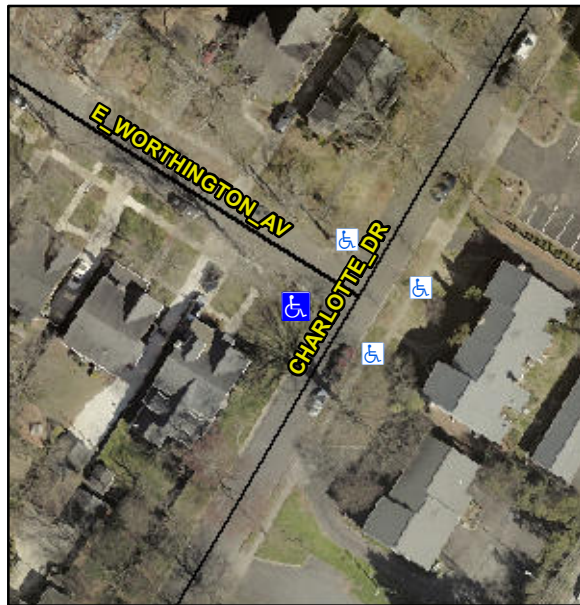
Compliance	Description	Data	Compliance	Description	Data
N/A	Ramp Length (in)	96.0	No	Ramp Slope (%)	18.4
Yes	Ramp Width (in)	48.0	Yes	Ramp XSlope (%)	2.1
N/A	Flare Type LT	N/A	N/A	Flare Type RT	N/A
N/A	Flare Slope LT (%)	N/A	N/A	Flare Slope RT (%)	N/A
N/A	Flare Traversable LT?	N/A	N/A	Flare Traversable RT?	N/A
N/A	Landing Length (in)	N/A	N/A	DWS Provided?	N/A
N/A	Landing Width (in)	N/A	N/A	DWS Contrast?	N/A
N/A	Landing Slope (%)	N/A	N/A	DWS Length (in)	N/A
N/A	Landing X Slope (%)	N/A	N/A	DWS Full Width?	N/A
N/A	Landing Curb? (Y/N)	N/A	N/A	DWS Offset (in)	N/A
N/A	Shared Landing?	N/A			
N/A	Gutter Ponding?	N/A	N/A	Gutter Slope (%)	N/A
N/A	Gutter Lip Ht (in)	3.0	N/A	Gutter X Slope (%)	N/A
N/A	Painted X Walk1?	No	N/A	Painted X Walk2?	N/A
	X Walk 1 Direction	To SE		X Walk 2 Direction	N/A
N/A	X Walk 1 Width (in)	N/A	N/A	X Walk 2 Width (in)	N/A
	X Walk 1 Slope (%)	2.0		X Walk 2 Slope (%)	N/A
	X Walk 1 X Slope (%)	6.2		X Walk 2 X Slope (%)	N/A

N/A	Ramp inside XWalk1?	N/A	N/A	Ramp inside XWalk2?	N/A
	Road Slope (%)	N/A	N/A	Clear Space?	N/A
	Road X Slope (%)	N/A	N/A	Clear Space to XWalk (in)	N/A
N/A	Any Obstructions?	N/A	N/A	Storm Grate/Utility Hazard?	N/A
	Obstruction Type			Storm Grate/Utility Type	
		N/A			N/A
			Yes	Surface Condition? (G/P)	Good

Remove & Replace Entire Ramp.
