# Access Compliance Report

## Public Rights-of-Way

### (Curb Ramps)

Intersection ID: 15555	Main Street: EASTOVER RIDGE DR	Cross Street: RANDOLPH RD	Location: SE
ADA ID: D70325F10292	Ramp Type: PerpDiag	Initial Pass/Fail: Fail	Overall Compliance: No
Codes/Mitigation Info/Possible Solution		Field Measurements/Component Compliance	
Severity Score: 12.5

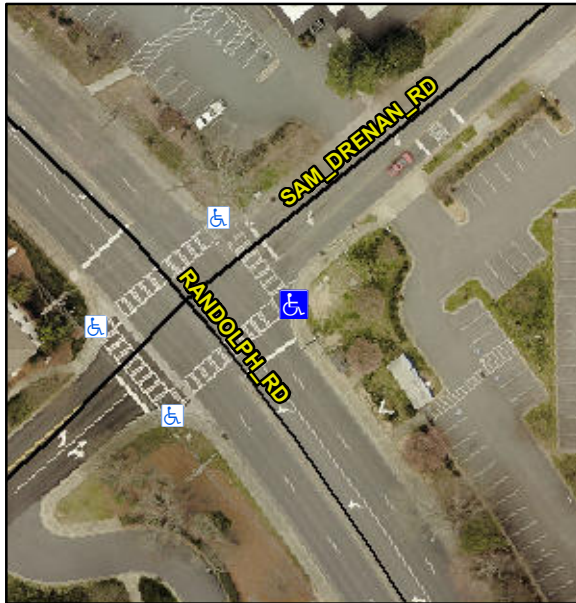
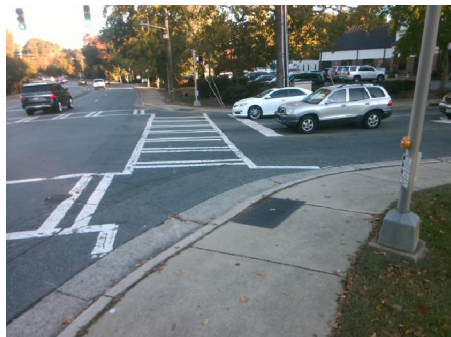
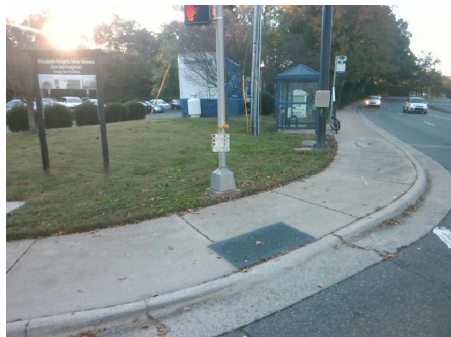
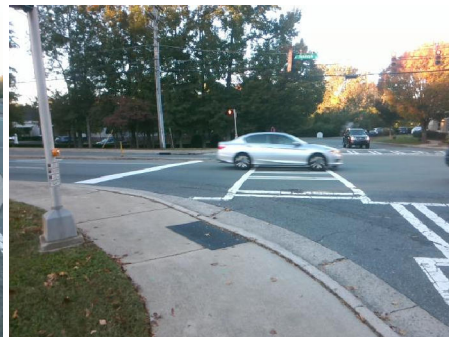
**Not Found, R304.5.3**

Compliance	Description	Data	Compliance	Description	Data
N/A	Ramp Length (in)	72.0	Yes	Ramp Slope (%)	6.1
Yes	Ramp Width (in)	48.0	No	Ramp XSlope (%)	5.2
N/A	Flare Type LT	N/A	N/A	Flare Type RT	N/A
N/A	Flare Slope LT (%)	N/A	N/A	Flare Slope RT (%)	N/A
N/A	Flare Traversable LT?	N/A	N/A	Flare Traversable RT?	N/A
N/A	Landing Length (in)	N/A	N/A	DWS Provided?	N/A
N/A	Landing Width (in)	N/A	N/A	DWS Contrast?	N/A
N/A	Landing Slope (%)	N/A	N/A	DWS Length (in)	N/A
N/A	Landing X Slope (%)	N/A	N/A	DWS Full Width?	N/A
N/A	Landing Curb? (Y/N)	N/A	N/A	DWS Offset (in)	N/A
N/A	Shared Landing?	N/A			
N/A	Gutter Ponding?	N/A	N/A	Gutter Slope (%)	N/A
N/A	Gutter Lip Ht (in)	N/A	N/A	Gutter X Slope (%)	N/A
N/A	Painted X Walk1?	Yes	N/A	Painted X Walk2?	Yes
	X Walk 1 Direction	To NW		X Walk 2 Direction	To SW
N/A	X Walk 1 Width (in)	102.0	N/A	X Walk 2 Width (in)	104.0
	X Walk 1 Slope (%)	2.8		X Walk 2 Slope (%)	0.7
	X Walk 1 X Slope (%)	6.3		X Walk 2 X Slope (%)	3.5

N/A	Ramp inside XWalk1?	Yes	N/A	Ramp inside XWalk2?	No
	Road Slope (%)	3.3	N/A	Clear Space?	N/A
	Road X Slope (%)	0.7	N/A	Clear Space to XWalk (in)	N/A
N/A	Any Obstructions?	N/A	N/A	Storm Grate/Utility Hazard?	N/A
	Obstruction Type			Storm Grate/Utility Type	
		N/A			N/A
		Yes		Surface Condition? (G/P)	Good

**Remove & Replace Curb Ramp With Two New Directional Ramps or Equivalent. Restripe Crosswalk.**
