# Access Compliance Report

## Public Rights-of-Way

### (Curb Ramps)

Intersection ID: 9794	Main Street: N_GARDNER_AV	Cross Street: W_TRADE_ST	Location:	E
ADA ID: D710DB3A49FA	Ramp Type: PerpDiag	Initial Pass/Fail: Fail	Overall Compliance: No	Severity Score: 12.5
Codes/Mitigation Info/Possible Solution		Field Measurements/Component Compliance

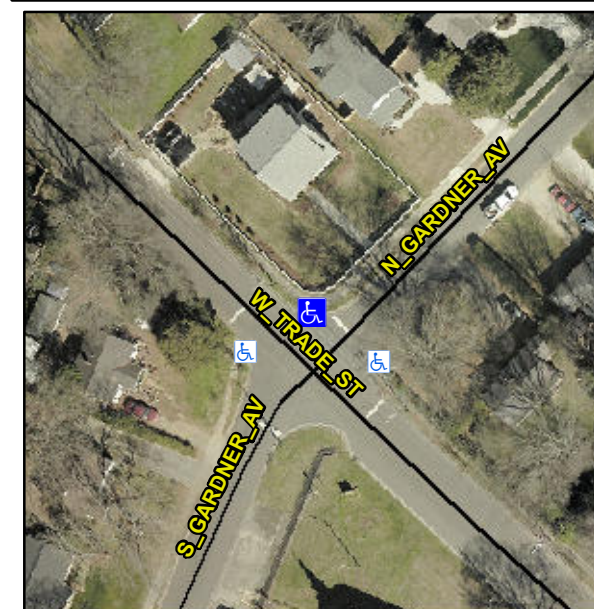
**Not Found, R304.5.3**

Compliance	Description	Data	Compliance	Description	Data
N/A	Ramp Length (in)	51.0	Yes	Ramp Slope (%)	7.8
Yes	Ramp Width (in)	48.5	No	Ramp XSlope (%)	5.1
N/A	Flare Type LT	N/A	N/A	Flare Type RT	N/A
N/A	Flare Slope LT (%)	N/A	N/A	Flare Slope RT (%)	N/A
N/A	Flare Traversable LT?	N/A	N/A	Flare Traversable RT?	N/A
N/A	Landing Length (in)	N/A	N/A	DWS Provided?	N/A
N/A	Landing Width (in)	N/A	N/A	DWS Contrast?	N/A
N/A	Landing Slope (%)	N/A	N/A	DWS Length (in)	N/A
N/A	Landing X Slope (%)	N/A	N/A	DWS Full Width?	N/A
N/A	Landing Curb? (Y/N)	N/A	N/A	DWS Offset (in)	N/A
N/A	Shared Landing?	N/A			
N/A	Gutter Ponding?	N/A	N/A	Gutter Slope (%)	N/A
N/A	Gutter Lip Ht (in)	0.5	N/A	Gutter X Slope (%)	N/A
N/A	Painted X Walk1?	No	N/A	Painted X Walk2?	No
	X Walk 1 Direction	To SW		X Walk 2 Direction	To SE
N/A	X Walk 1 Width (in)	N/A	N/A	X Walk 2 Width (in)	N/A
	X Walk 1 Slope (%)	1.6		X Walk 2 Slope (%)	4.6
	X Walk 1 X Slope (%)	5.4		X Walk 2 X Slope (%)	0.3

N/A	Ramp inside XWalk1?	N/A	N/A	Ramp inside XWalk2?	N/A
	Road Slope (%)	4.7	N/A	Clear Space?	N/A
	Road X Slope (%)	4.0	N/A	Clear Space to XWalk (in)	N/A
N/A	Any Obstructions?	N/A	N/A	Storm Grate/Utility Hazard?	N/A
	Obstruction Type			Storm Grate/Utility Type	
		N/A			N/A
		Yes		Surface Condition? (G/P)	Good

**Remove & Replace Curb Ramp With Two New Directional Ramps or Equivalent.**

Total Cost: \$ 3200.00
