Access Compliance Report

Public Rights-of-Way

(Curb Ramps)

Intersection ID: 19036	Main Street: RANDOLPH_RD	Cross Street: RANDSTONE_CT	Location:	N
ADA ID: D7166F81522D	Ramp Type: PerpDiag	Initial Pass/Fail: Fail	Overall Compliance: No	Severity Score: 22.5
Codes/Mitigation Info/Possible Solution		Field Measurements/Component Compliance

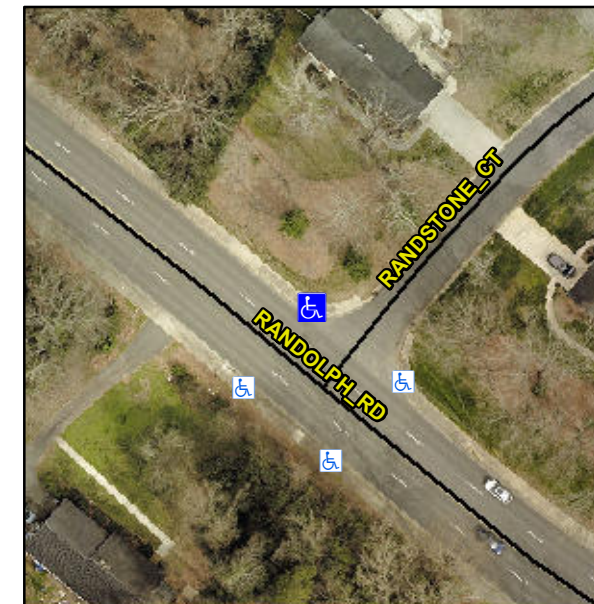
Not Found, R304.5.1, R304.2.2, R304.5.3

Compliance	Description	Data	Compliance	Description	Data
N/A	Ramp Length (in)	61.5	No	Ramp Slope (%)	9.1
No	Ramp Width (in)	47.0	No	Ramp XSlope (%)	3.8
N/A	Flare Type LT	N/A	N/A	Flare Type RT	N/A
N/A	Flare Slope LT (%)	N/A	N/A	Flare Slope RT (%)	N/A
N/A	Flare Traversable LT?	N/A	N/A	Flare Traversable RT?	N/A
N/A	Landing Length (in)	N/A	N/A	DWS Provided?	N/A
N/A	Landing Width (in)	N/A	N/A	DWS Contrast?	N/A
N/A	Landing Slope (%)	N/A	N/A	DWS Length (in)	N/A
N/A	Landing X Slope (%)	N/A	N/A	DWS Full Width?	N/A
N/A	Landing Curb? (Y/N)	N/A	N/A	DWS Offset (in)	N/A
N/A	Shared Landing?	N/A			
N/A	Gutter Ponding?	N/A	N/A	Gutter Slope (%)	N/A
N/A	Gutter Lip Ht (in)	N/A	N/A	Gutter X Slope (%)	N/A
N/A	Painted X Walk1?	No	N/A	Painted X Walk2?	No
	X Walk 1 Direction	To SW		X Walk 2 Direction	To SE
N/A	X Walk 1 Width (in)	N/A	N/A	X Walk 2 Width (in)	N/A
	X Walk 1 Slope (%)	2.4		X Walk 2 Slope (%)	3.7
	X Walk 1 X Slope (%)	3.1		X Walk 2 X Slope (%)	1.6

N/A	Ramp inside XWalk1?	N/A	N/A	Ramp inside XWalk2?	N/A
	Road Slope (%)	2.4	N/A	Clear Space?	N/A
	Road X Slope (%)	0.5	N/A	Clear Space to XWalk (in)	N/A
N/A	Any Obstructions?	N/A	N/A	Storm Grate/Utility Hazard?	N/A
	Obstruction Type			Storm Grate/Utility Type	
		N/A			N/A
			Yes	Surface Condition? (G/P)	Good

Possible Solutions:

Remove & Replace Curb Ramp With Two New Directional Ramps or Equivalent.
